FAULT ON PROPERTY OF MR. HARRY GRANT IN WHITEFISH BAY

E.F. Bean

Open-File Report 27-1  
3 p.

1927

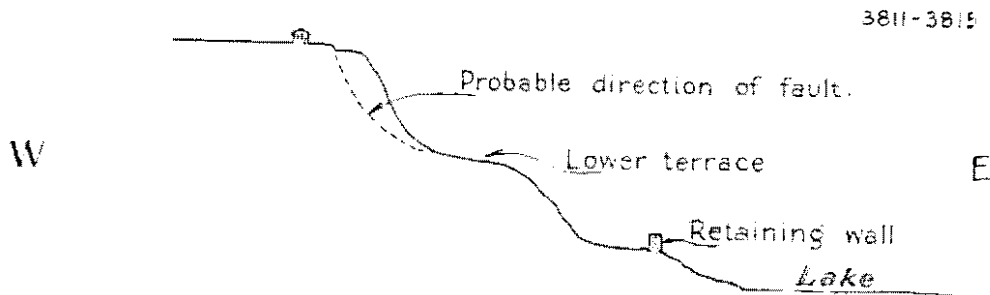
The upland upon which the homes are built is about 100 feet above the lake. This has been stable for many years as indicated by

the presence of very old oak trees. The bluff has not been in equilibrium for so long a time as the tree growth is relatively young. The lower terrace is probably a landslide terrace formed by the sliding of a mass of clay from the bluff above.

The material in the bluff is largely clay. The contractor reports lenses of sand. These would carry water and lubricate the underlying clay and on a steep slope furnish conditions favoring a slide.
