A WEATHERING STUDY OF THE UNIVERSITY BUILDINGS

Burton E. Karges

CIVIL WORKS ADMINISTRATION

PROJECT 79.42

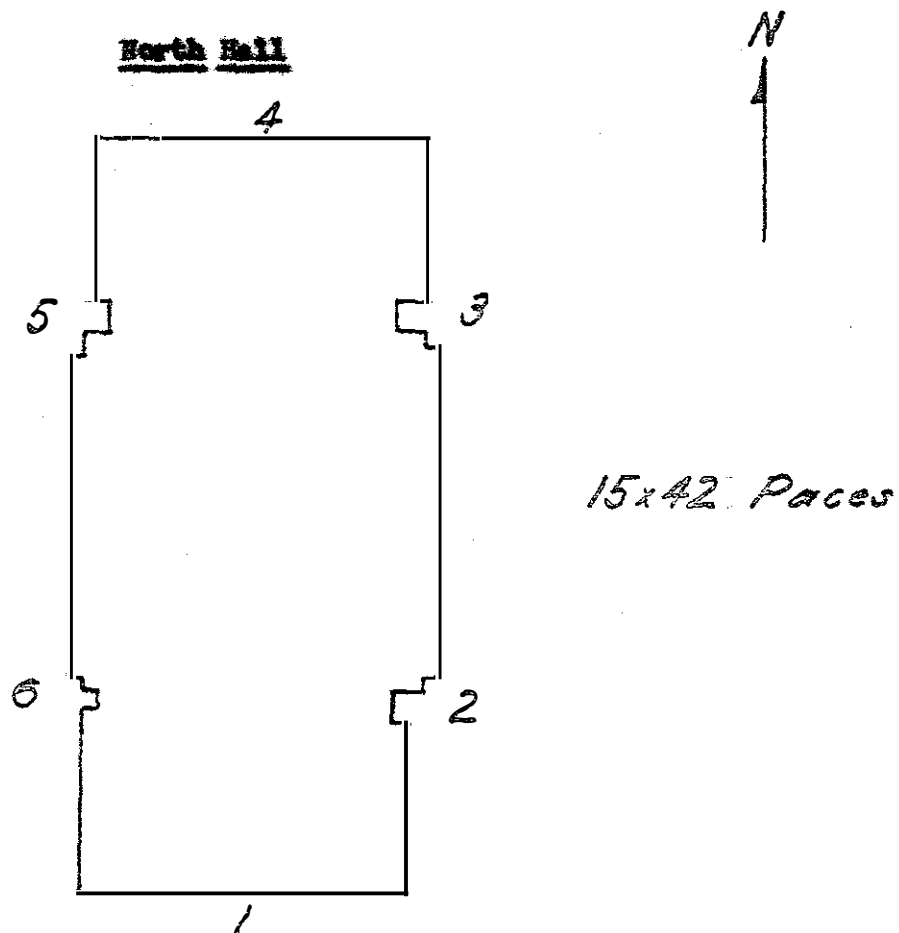
In general the stone is in good condition. Exceptions are found in the lower  $3\frac{1}{2}$  feet, under the windows, and beside the SW eave trough. What weathering there is, is due chiefly to poor placing of the stone both in relation to the position of the bedding planes and in positions where it is easily attacked by water.

Below the belt course -- large blocks make up the foundation. The blocks are in almost every instance placed with the bedding in vertical position and have been freely attacked by weathering. 90% of the rock has been weathered and in 70% of the area the depth affected is from  $\frac{1}{2}$  to  $1\frac{1}{2}$  inches. In most cases the damage has been done by spalling off due to weaker layers inside; some, however, is just a grain by grain disintegration as the loss of cement and freezing and thawing have gone on. Fine grained silty stone is the most affected.

Above this heavy layer weathering is conspicuous beneath the window sills, where it extends to a depth of  $\frac{1}{4}$  to  $1/5$  of an inch (or perhaps even a little more), and on the lower half of the south side of the SW corner. This looks as if it were due to a defective down spout.

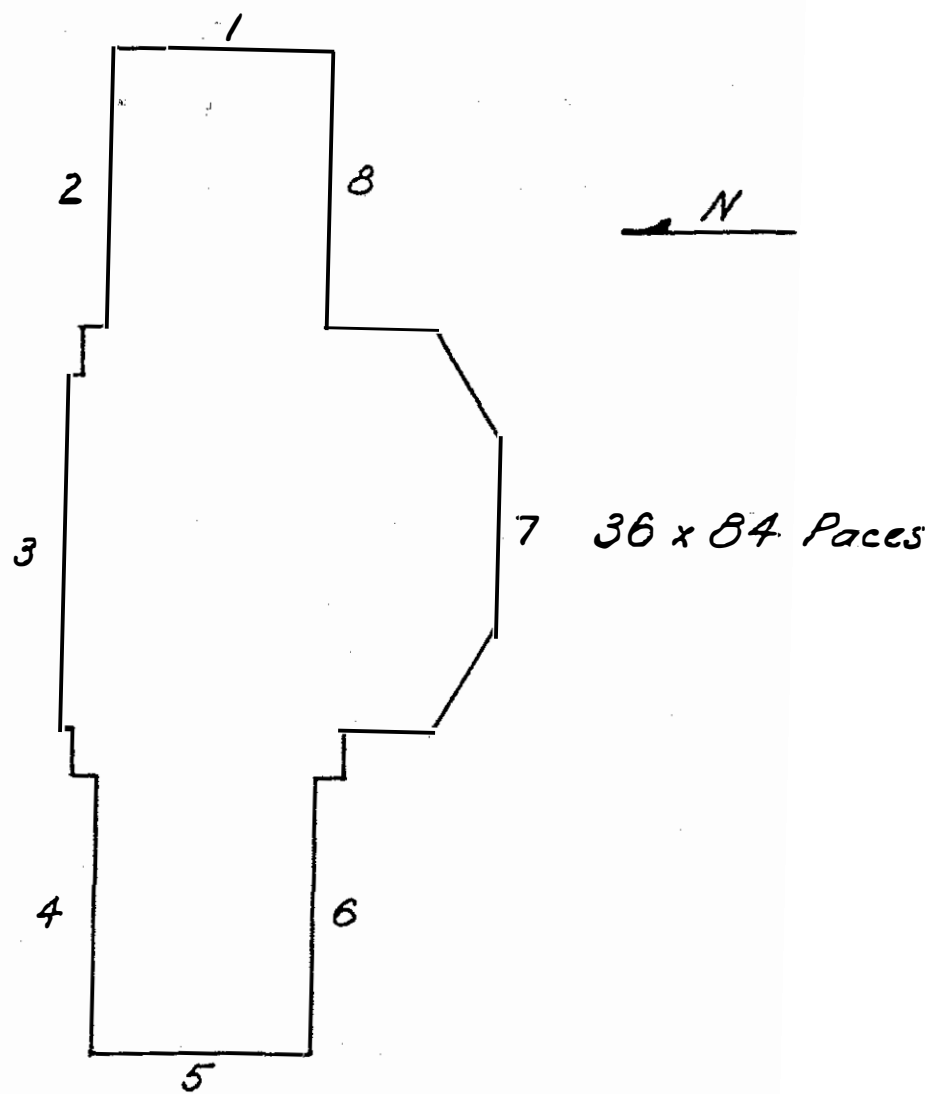
BIOLOGY BUILDING

At this end the worst weathering is found in the two lower courses.

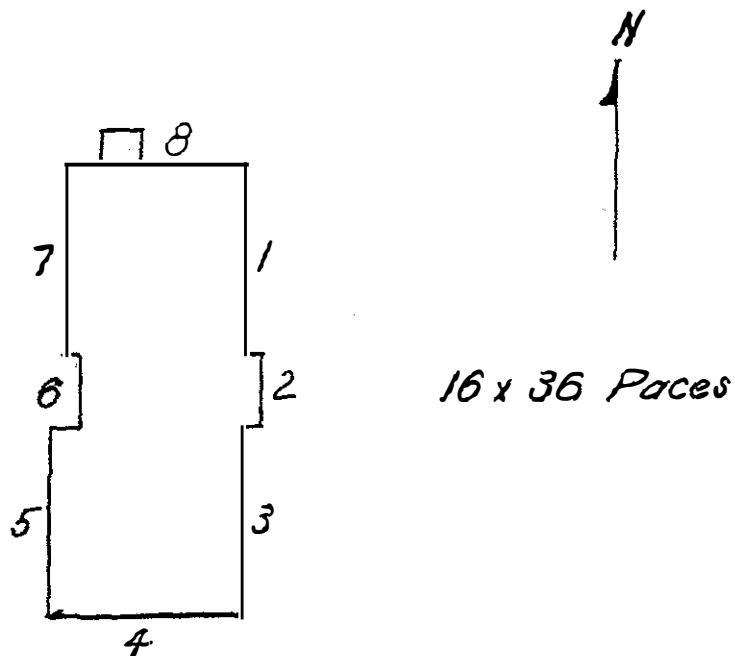
Administration Building

Below the 7 inch belt course of Madison sandstone, the foundation is made up of a 12 inch course of Madison laid on edge and below this part of another course is exposed before the soil level is reached. Fully 75% of this 12 inch course is badly spalled off to a depth of  $\frac{1}{2}$  to 1 inch. Weathering is in the form of thin sheets spalling off due to silty lenses and is facilitated by capillary water drawn up into the wall. The belt course shows decay in 80% of its length to a depth of  $\frac{1}{4}$  to  $\frac{3}{4}$  of an inch. This is confined to the lower part of this course except in <sup>two</sup> blocks which show numerous worm tubes. These, while not so deeply decayed (only  $\frac{1}{3}$  an inch) are weathered on the whole face. The tubes here are resistant and the silty material weathers from around them.

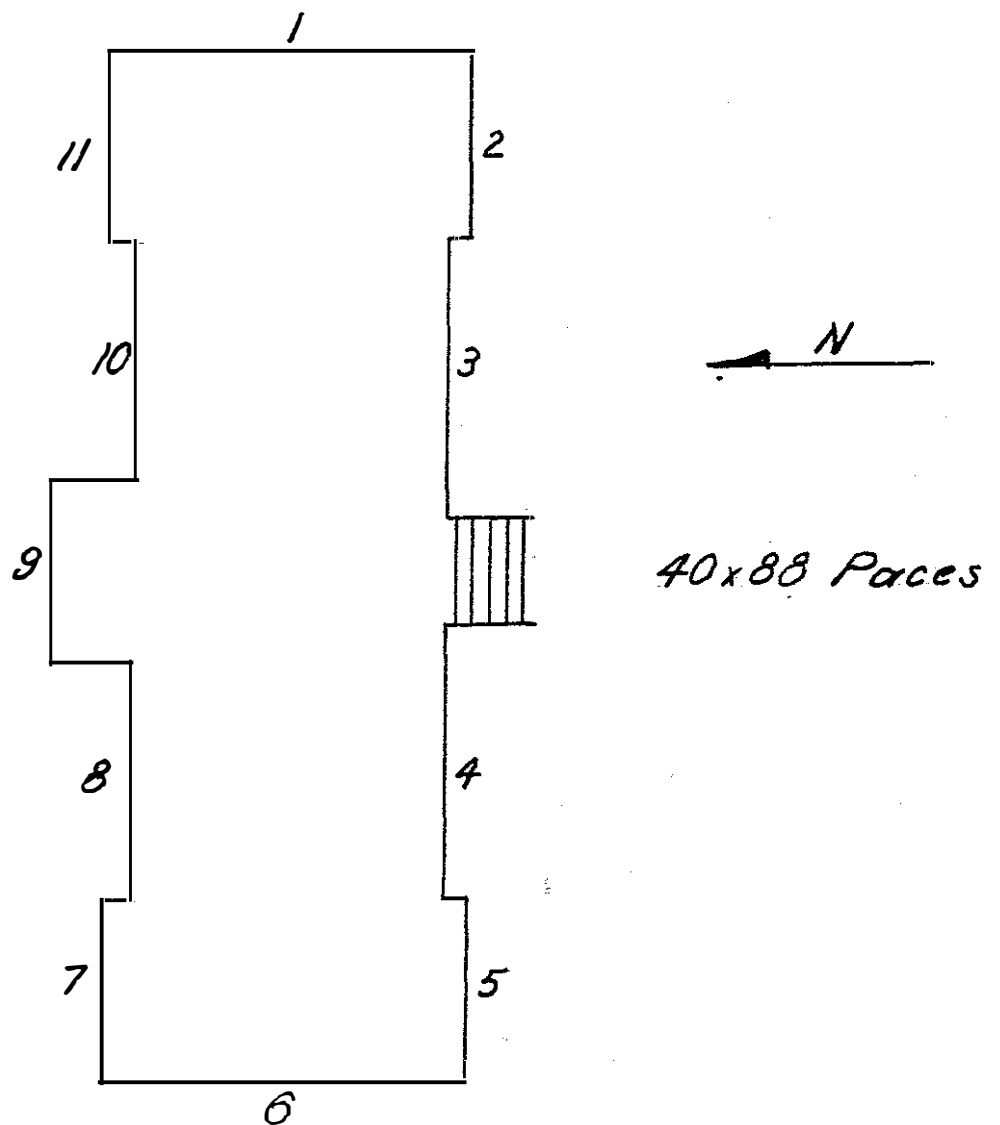
Lathrop Hall.

25% of the stone in the lowest course has decayed and is spalling off to depths of  $1/4$  to  $5/8$  of an inch. A casehardened shell is present here. Once this is broken through, the siltier portions weather out and the sheets of the outer shell spall off.

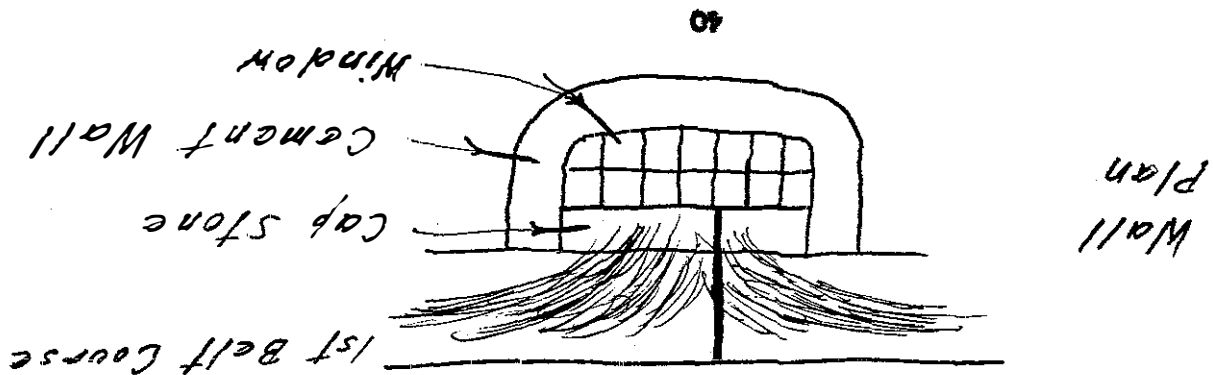
Three of the five flush set window sills of the first floor show small weathered patches where the outer surface has peeled off in front of small silty patches. The depth penetrated does not exceed  $1/8$  of an inch. The remainder of the stone in first floor courses and in lower belt course 2 A

In the weathering of the lower course and the basement window capping stones.

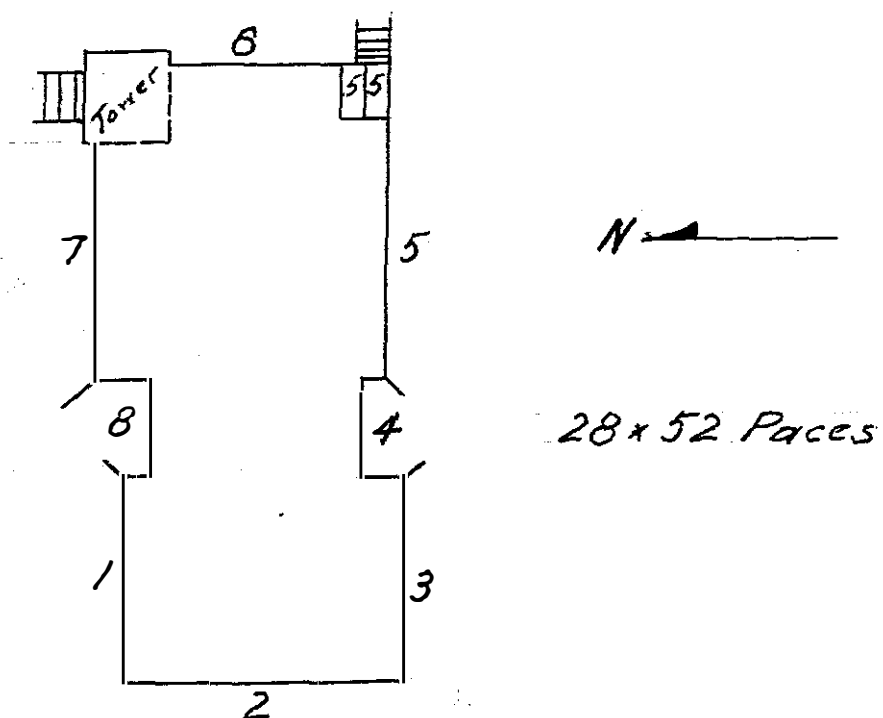
Music Hall.

The courses below the first belt course in this location have been patched with mortar in about 25-30% of their area. The patching is holding very well. Over half of the remaining stone is weathered  $1/8$  -  $1/4$  of an inch by spalling due to silty splashes.

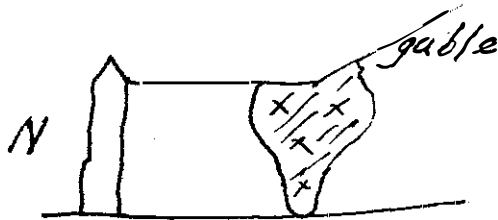
The largest weathered area on the west wall is located below the joint of the gable and horizontal cornices in the north half of the wall.

The area is roughly funnel shaped, being 12 feet wide at the top, just under the cornice, and tapering down to 5 feet at the top of the first belt course. In this area the spalling of small pieces has been about equal with grain by grain disintegration. The average depth affected is a bit less than  $3/8$  of an inch, but a few stones have been penetrated  $5/8$  of an inch. The red sandstone has also decayed from  $1/8$  -  $3/8$  of an inch. Thin sheets have spalled off, probably due to a leaching of their cementing material. To still further spoil the appearance of the wall, a roughly circular area some 6 feet in diameter is covered with sickly white efflorescence.

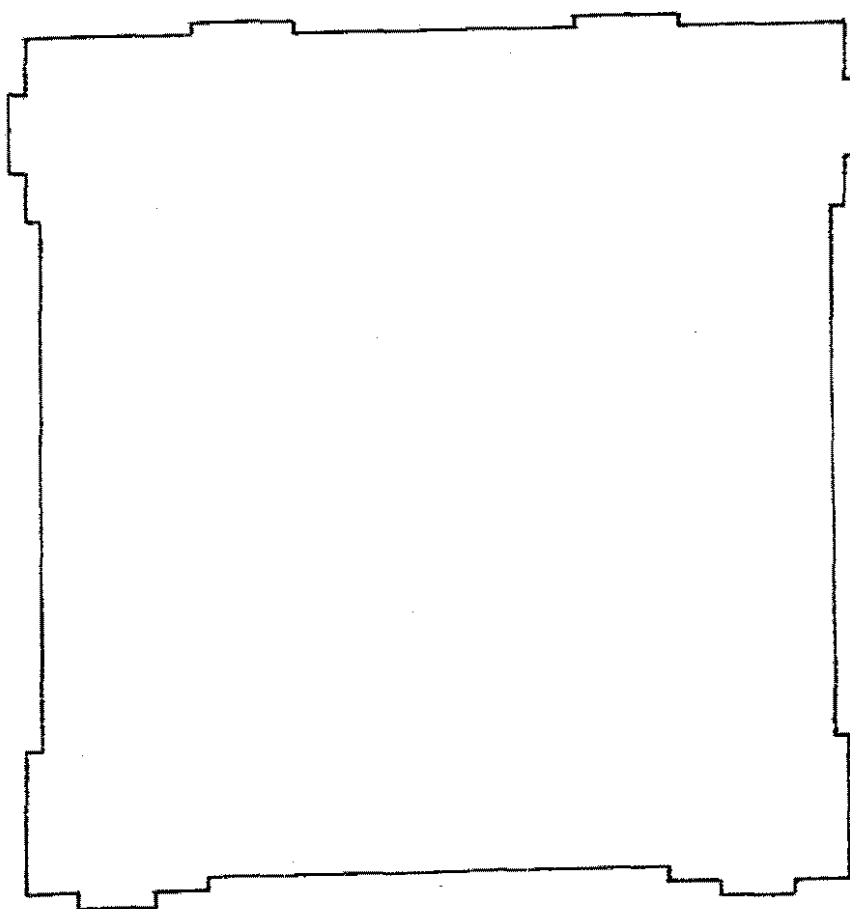
Mechanical Engineering Building.

There is a group of four belt courses at the top of the third floor window, the upper one of which projects out at least 18 inches from the wall. Here there is very adequate protection from water running back on to the wall in the form of a heading (x)

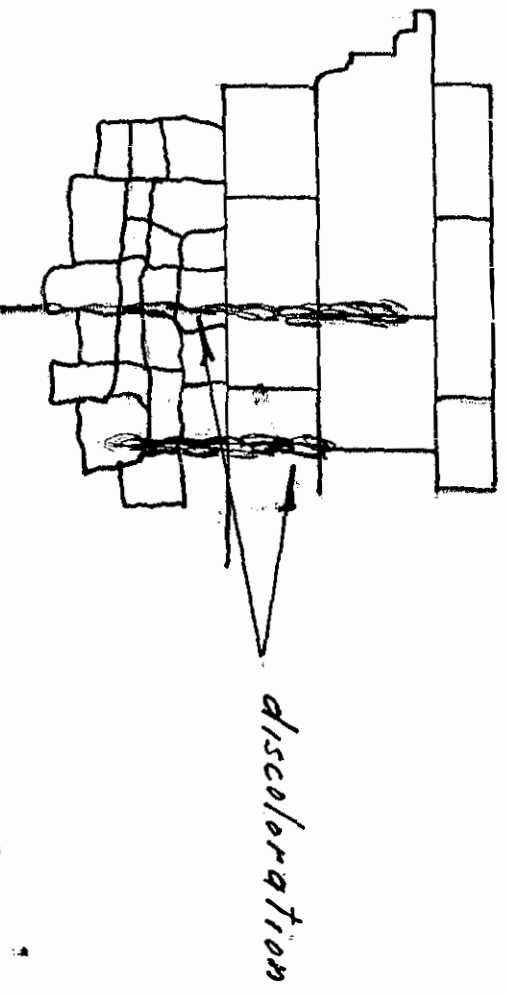
In the belt course below the third floor windows, the same thing takes place because the underside of the projecting course is not properly grooved. Here the joints are staggered (see sketch) and it is clearly seen that the joints of the projecting course are the offenders.

Just why this discoloration is so much more marked on the East side is a puzzle. It may perhaps be related to the greater exposure to smoke from the university heating plant.

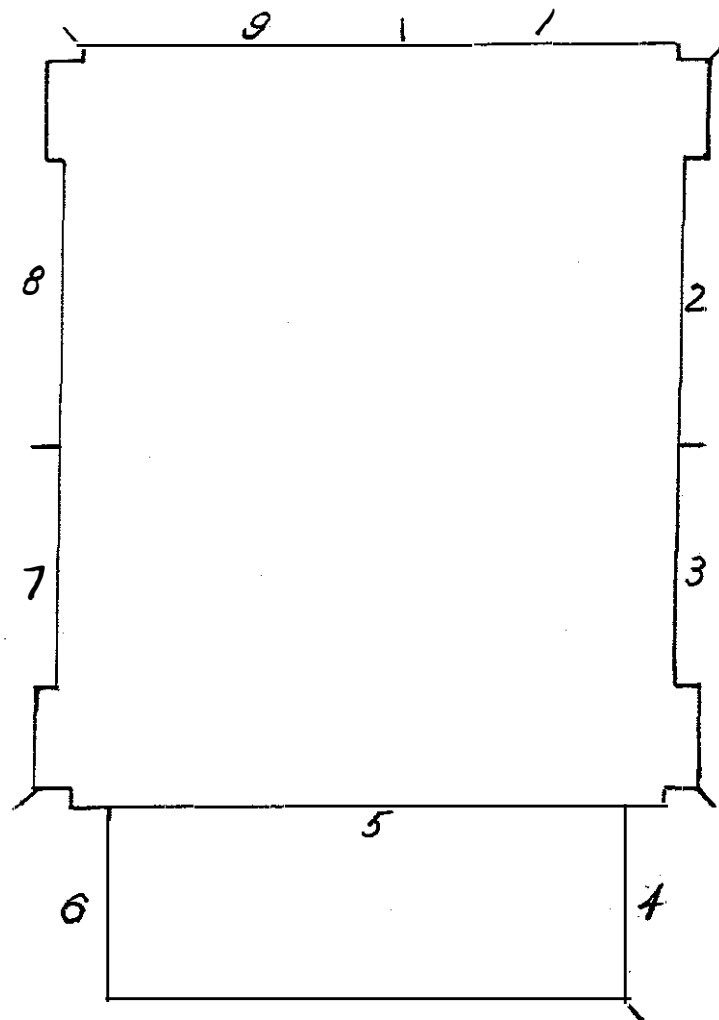
University Field House.

The field house was completed in 1930. Madison sandstone was used for facing the structure and terra cotta was used for two wide belt courses just above grade level. For door frames, window sills and other belt courses.

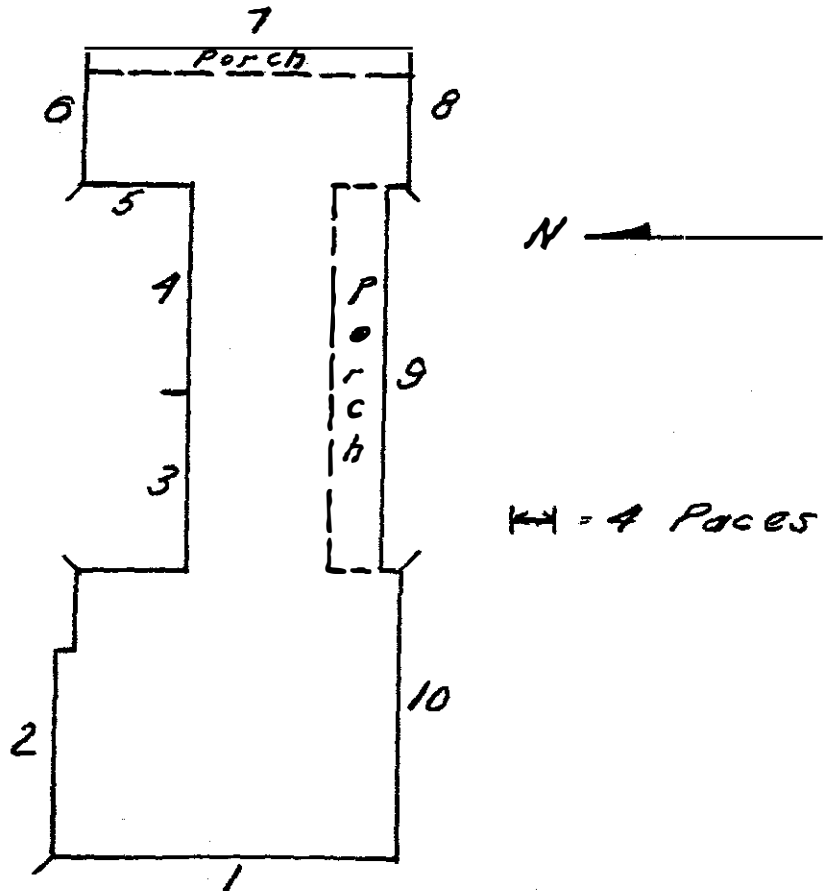
Chadbourne Hall.

weathering  $\frac{1}{4}$  -  $\frac{3}{4}$  of an inch has taken place. The weathering of silt-filled worm tubes and spalling in front of silty blotches is clearly illustrated here.

3. There are small discolored streaks below where fire-escape braces enter the wall and also at the ends of several of the window sills. Four or five blocks show a minor amount of white efflorescence.

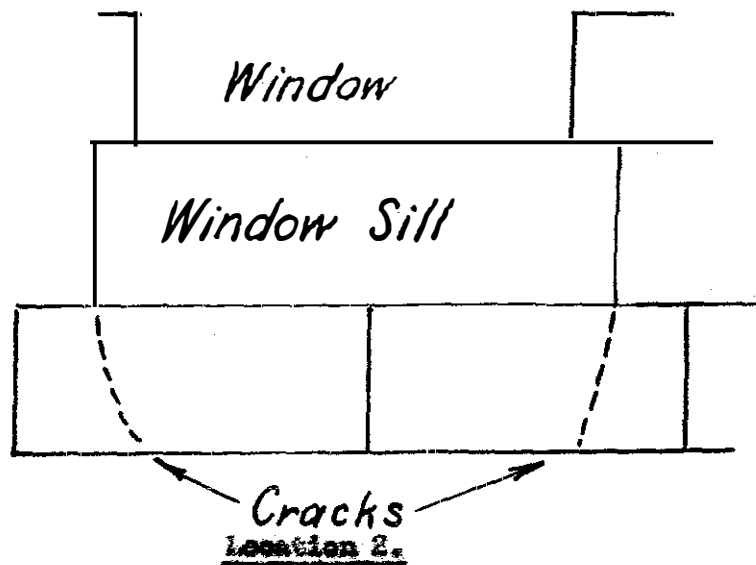
A serious mistake was made in the placing of the stones below the first floor windows. Cracks cutting across the limestone blocks are seen below practically every window, thus:--

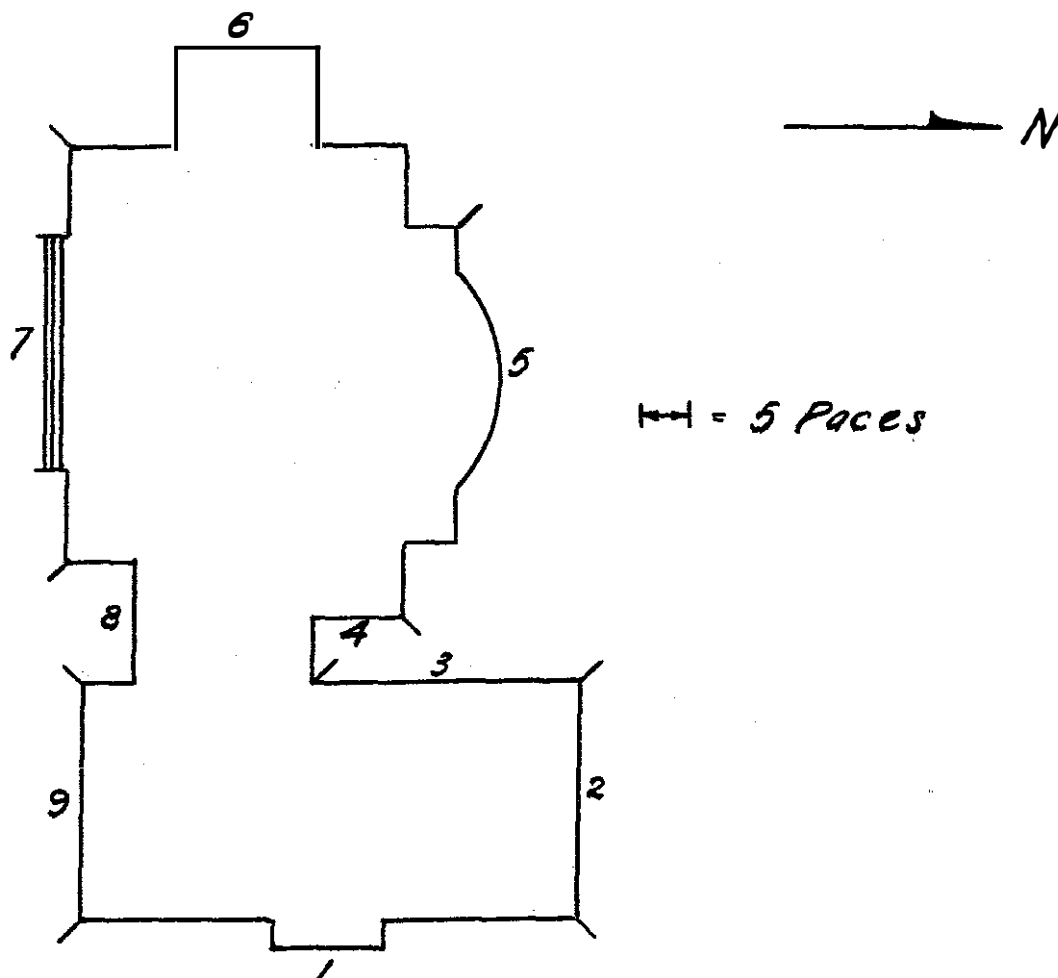
Memorial Union.

The Bedford limestone of the first floor wall is in very fine condition. The upper courses are slightly streaked with discoloration below the belt course at the top of the limestone. This is due to the sloping shelf formed by the setting in of the wall above the limestone, so that dirty water collects and stains the limestone.
