STABILITY OF ROCK MASSES ON EAST SIDE OF ROCKY GORGE,  
MANITOU FALLS AREA, PATTISON STATE PARK

Open-File Report 75-1  
7 p.

REPORT FOR WISCONSIN DEPARTMENT OF NATURAL RESOURCES

Joseph T. Mengel, Jr.  
Geosciences Department  
University of Wisconsin - Superior

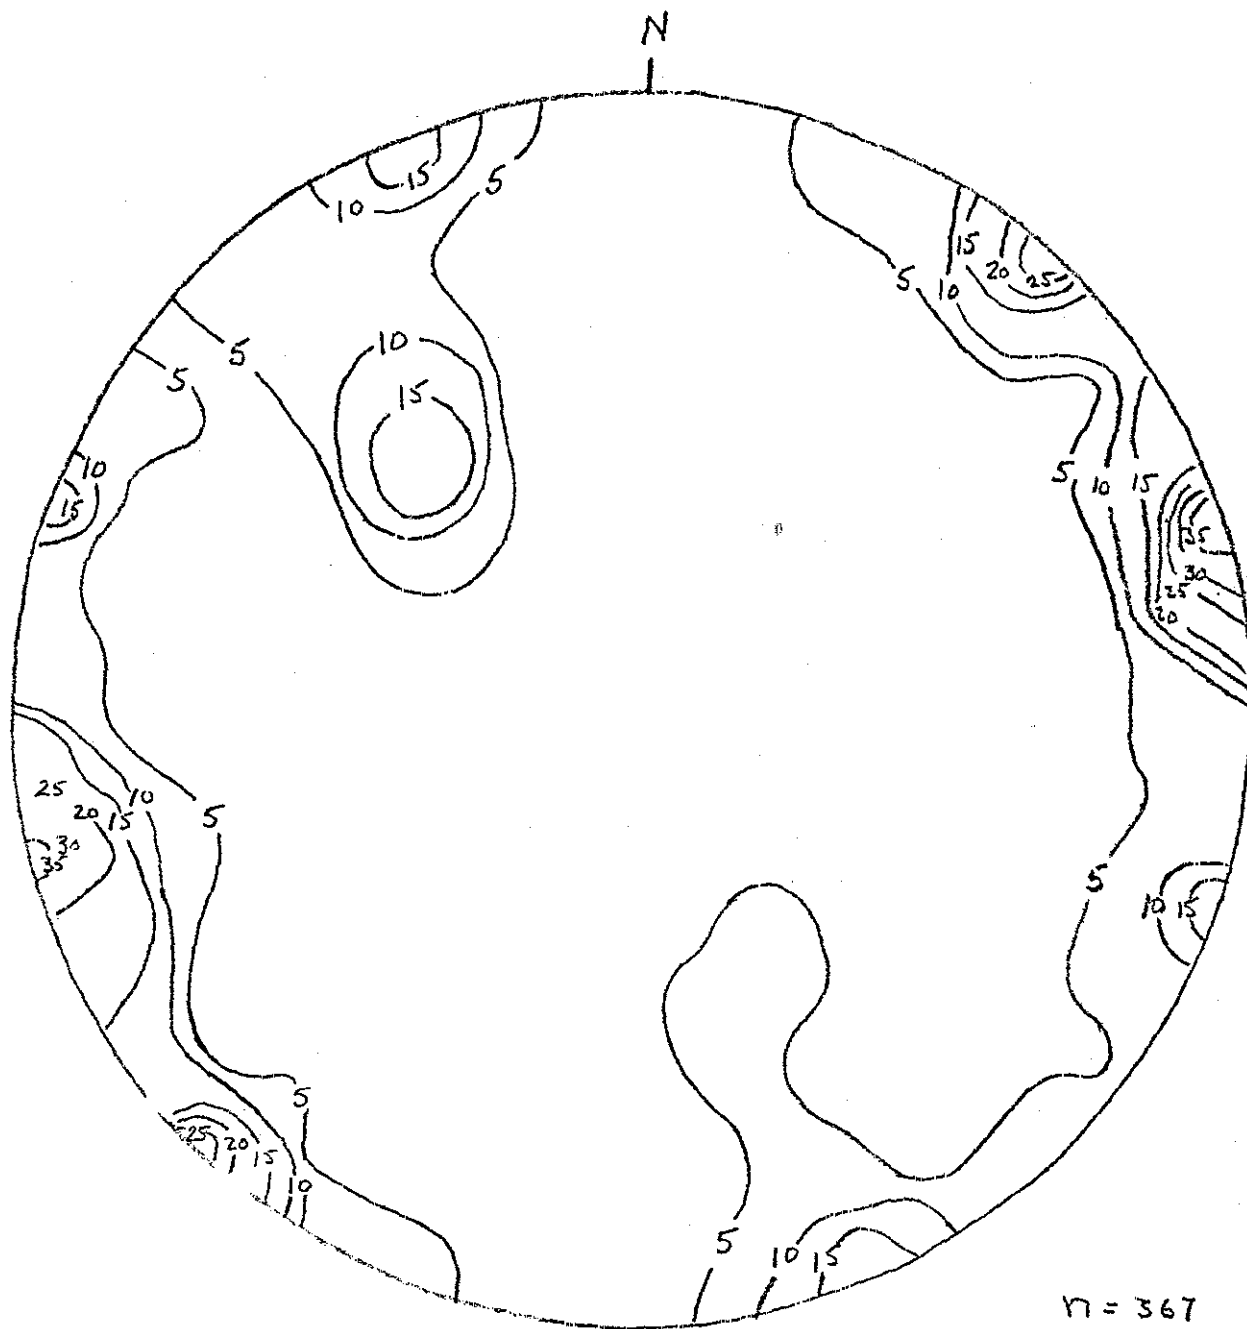
Figure 1.  
Fracture System of Rock Masses East Side  
Rocky Gorge, Manitou Falls Area

The fracture system in the rock mass in the study area is represented on Figure 1. Table 1 summarizes the principal attitudes represented in Figure 1, as does Figure 2.

1. Strike N15E; Dip vertical
2. Strike N50E; Dip 45°S approximate layering direction\*
3. Strike N65E; Dip vertical
4. Strike N15W; Dip vertical
5. Strike N50W; Dip vertical

A subordinate fracture development with a N50E-45S attitude is also apparent in Figure 1.

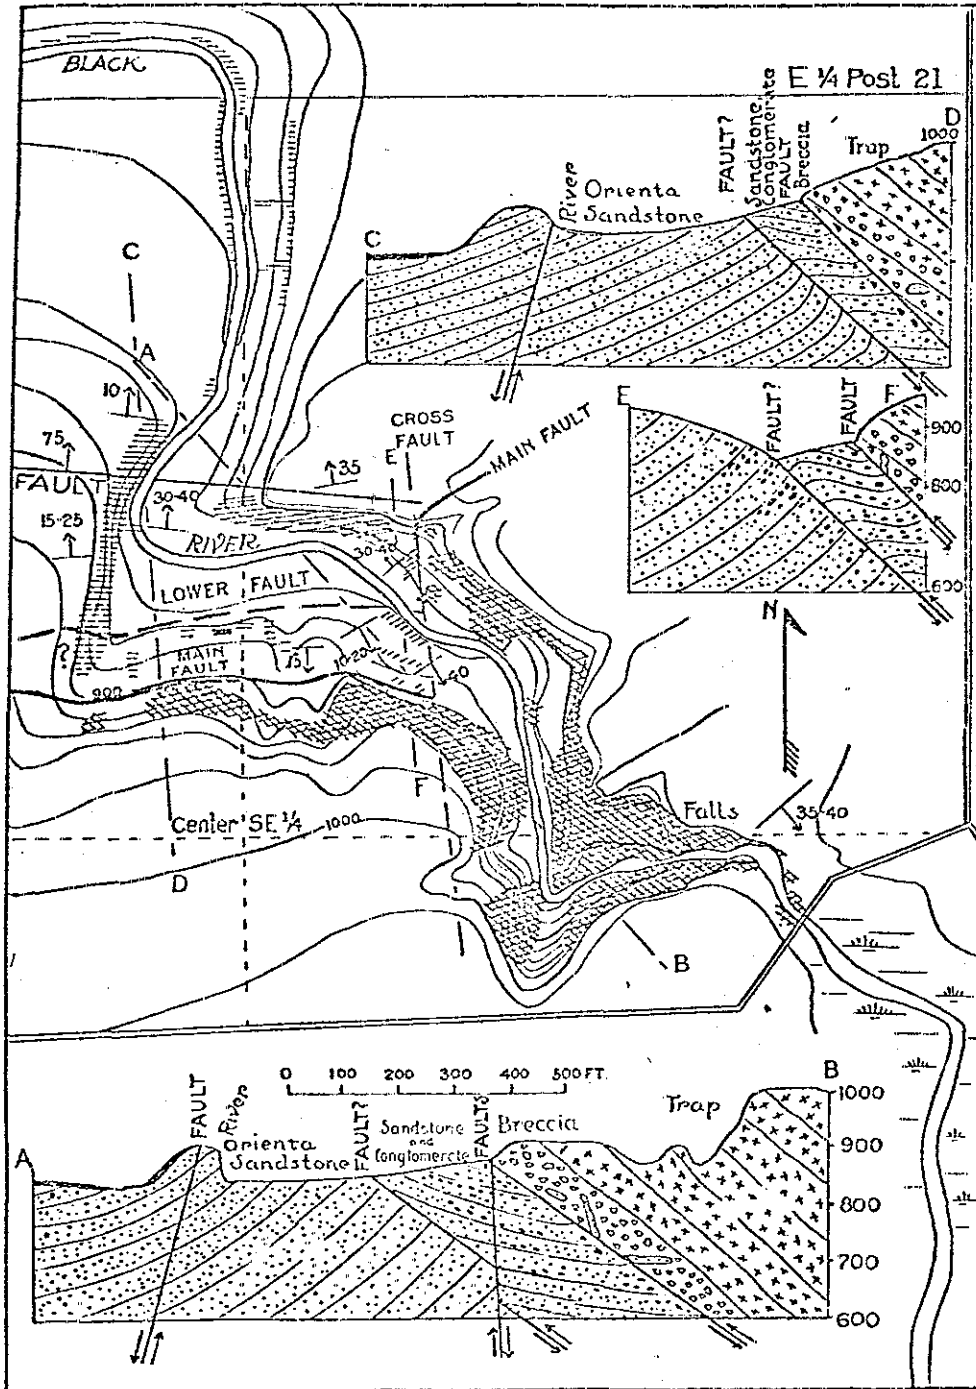
Figure 3.

The fracture sets making up the fracture system of the study area are sympathetic in their attitudes to those of the major fractures known or inferred in the vicinity. Figure 3, taken from Thwaites (1912, Plate 29) shows faults observed by Wisconsin Geological and Natural History Survey workers. Careful examination of U. S. Geological Survey Sunnyside and Patzau 7 1/2 minute topographic maps shows that the drainage pattern in the vicinity of the Park is strongly influenced by the observed fracture attitudes listed in Table 1.

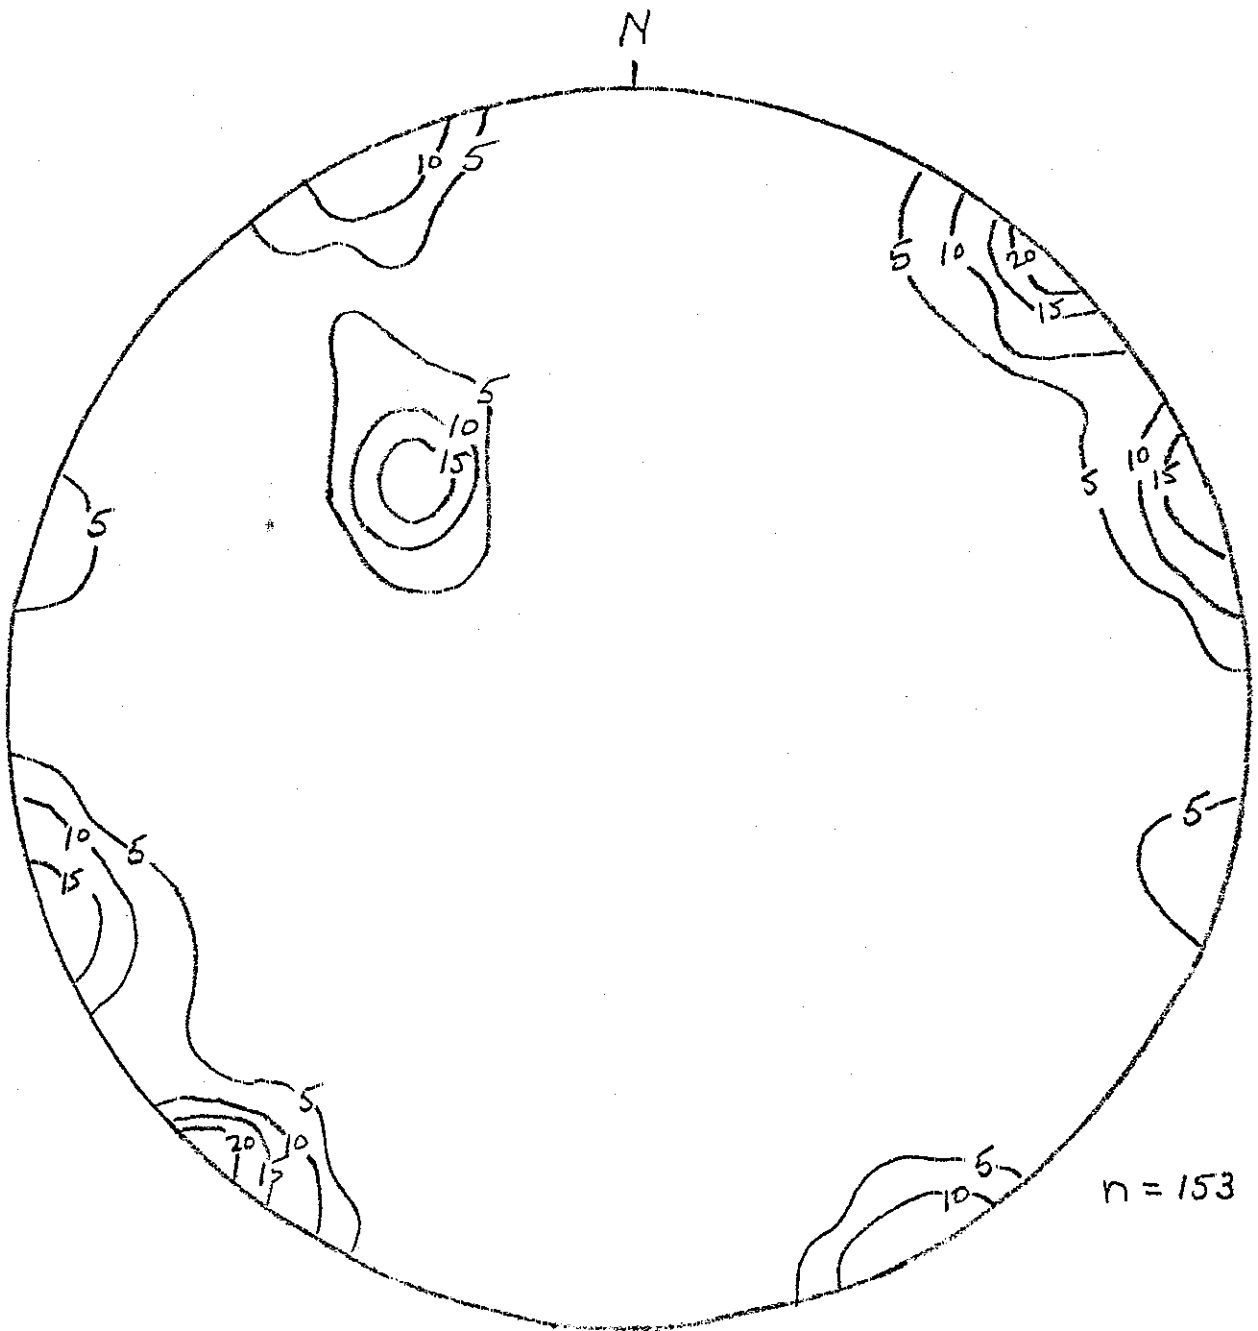
Figure 4  
Fracture System on and Below South Overlook

Figure 4 shows the attitudes of fractures observed on and below the south overlook. The general soundness of the rock between fractures, the generally wide gaps of sound rock between fractures and the minor degree to which any fractures are fissured suggest that this overlook will continue to be stable for many years.

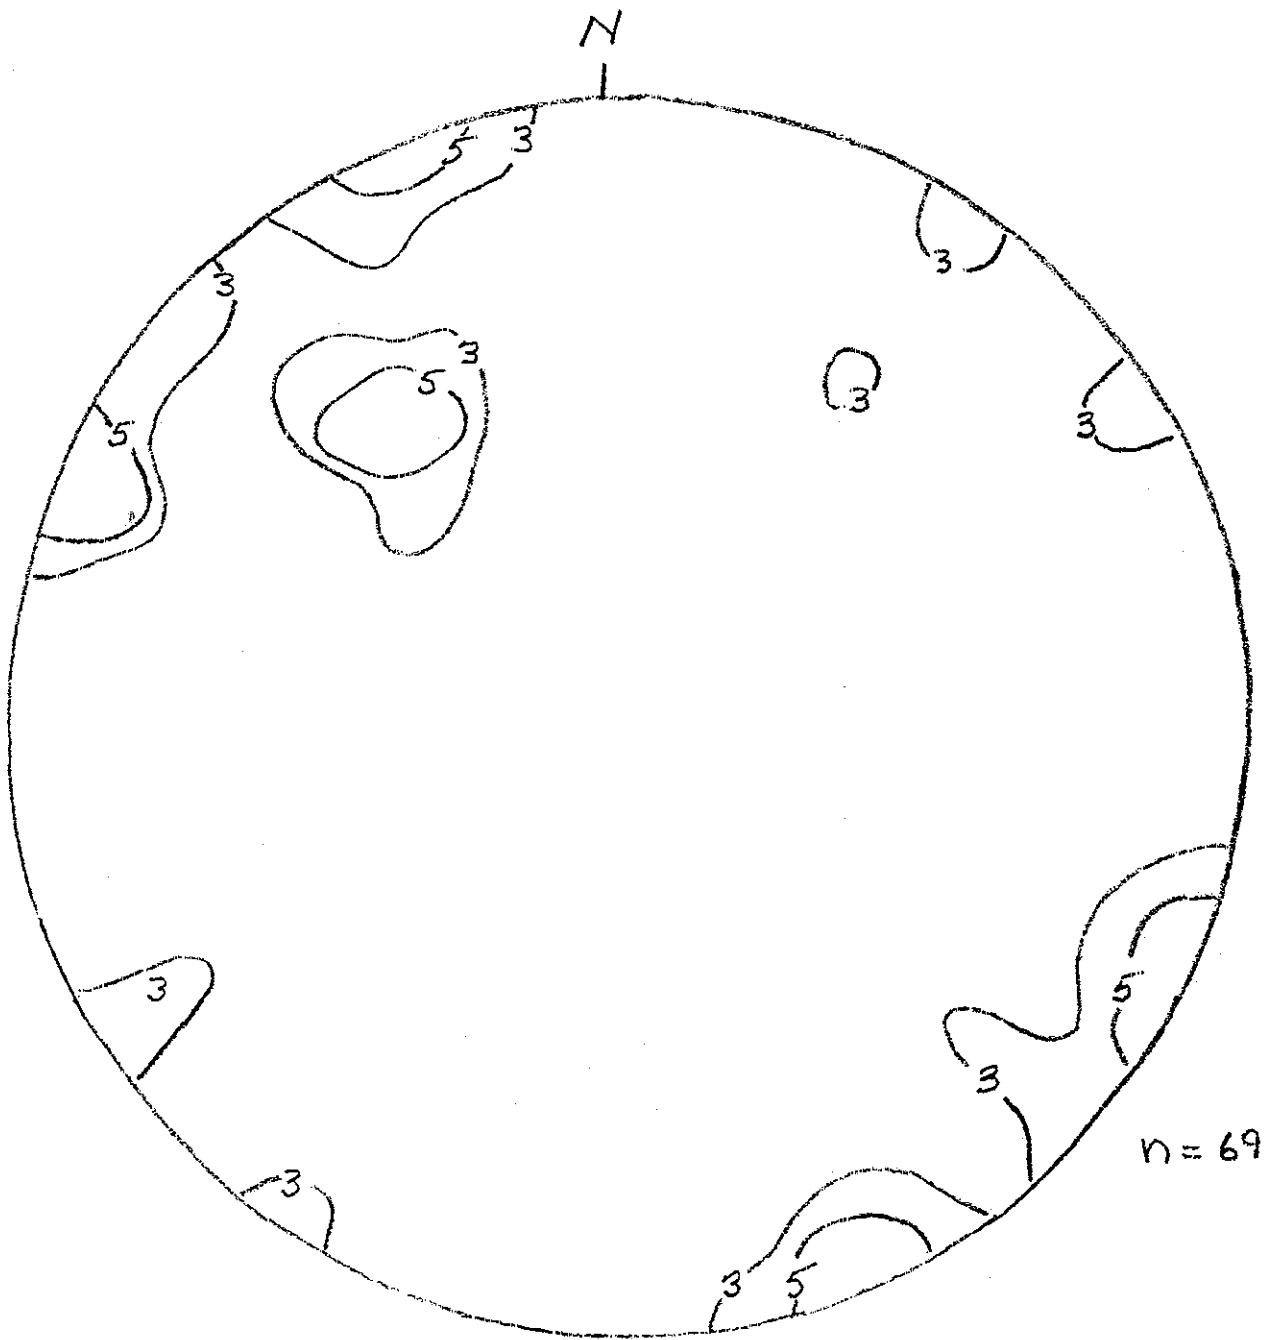
Figure 5.

Figure 5 ~~2~~ shows the attitudes of fractures observed in and below the north overlook. Fewer observations are plotted on this Figure because brecciation of the rock mass in this vicinity prevents making large numbers of attitude determinations. Figure 6 shows the shape of the overlook. Stipple pattern 1 designates an overhanging mass of brecciated lava which is potentially dangerous and should be removed. This brecciated mass probably also threatens the present foundation in this portion of the overlook. Movement of the platform limit 3-6 feet inward from the present railing in this area would alleviate this danger.

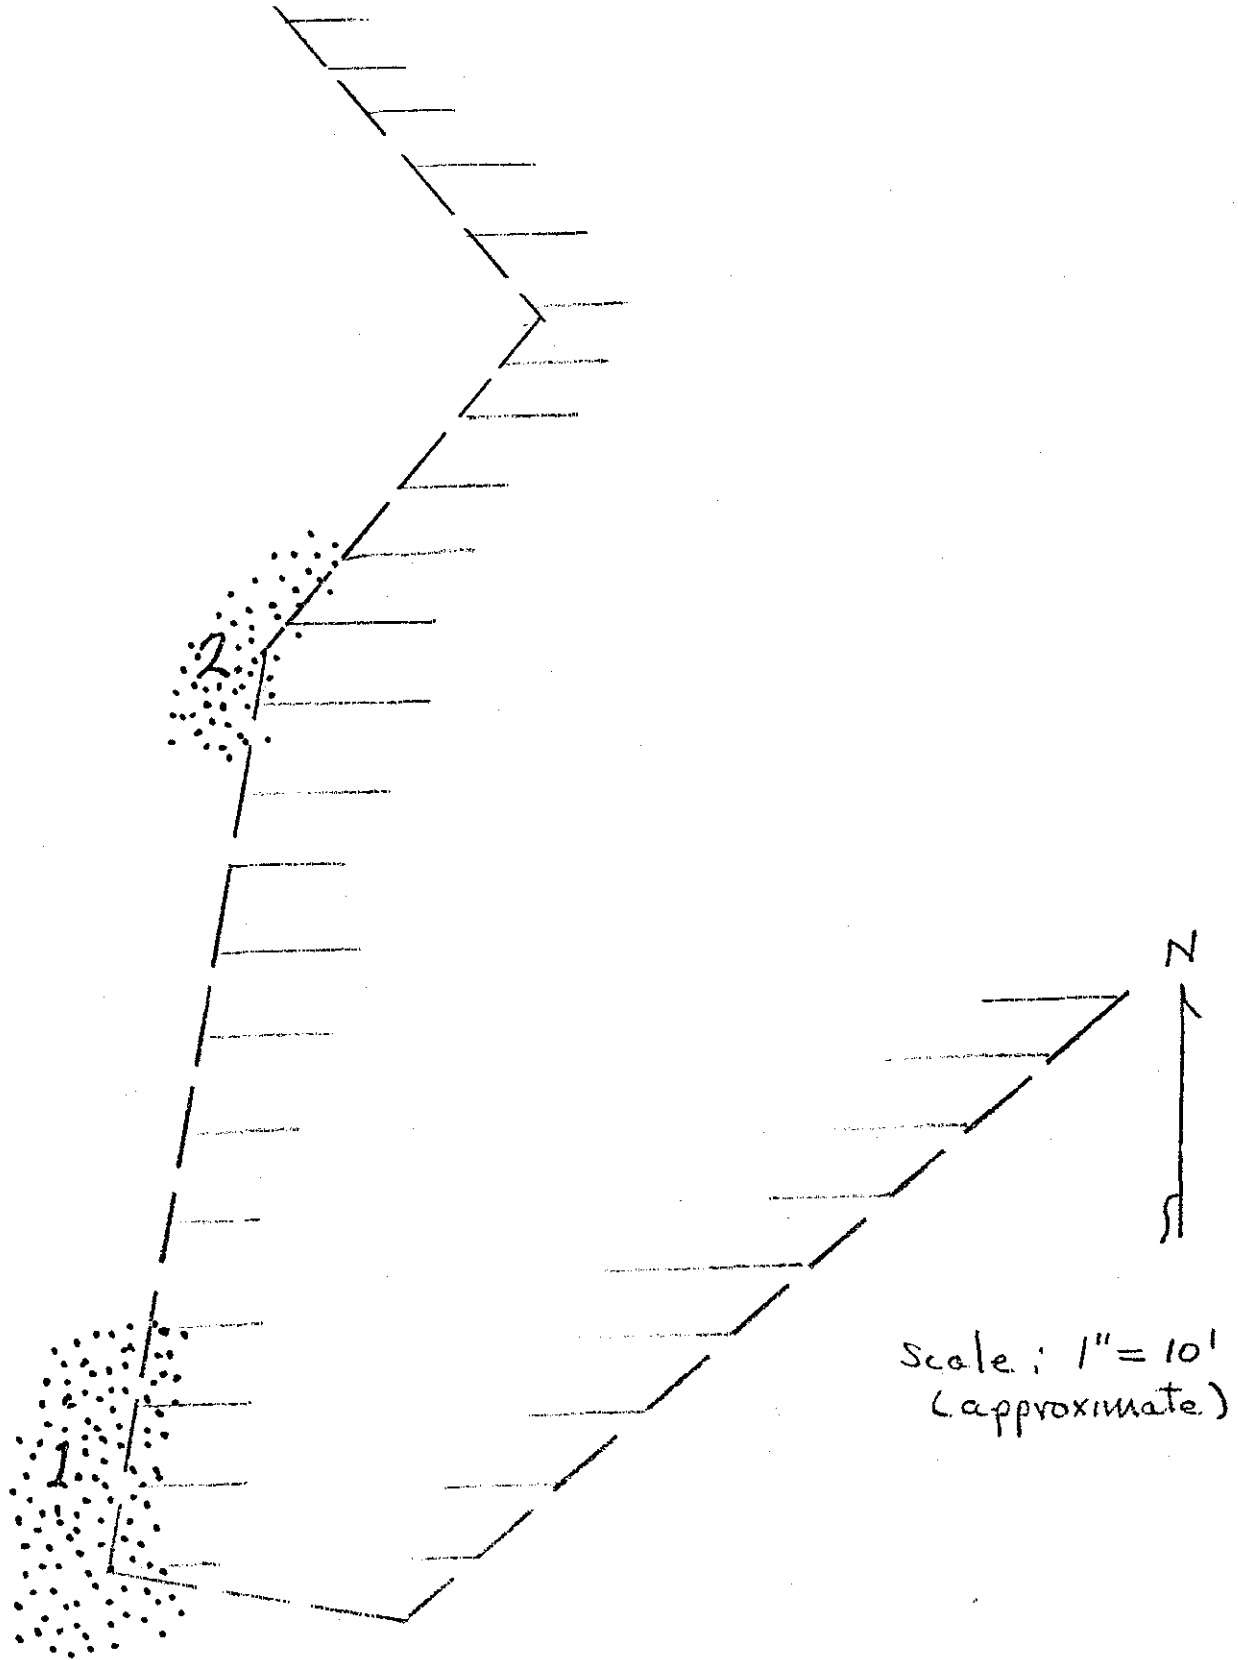
Figure 6  
North Overlook Platform Unstable Areas

Stipple pattern 2 designates an area of fissured overhang. Fissuring in this area is larger but less pervasive than in area 1 and is developed along less steeply inclined fractures. Stabilization of the fissured zone through cleaning and concreting or other means should alleviate the danger in this area.

Both platforms should be kept as watertight as possible to minimize frost wedging and pore water pressure in the fracture-fissure systems.

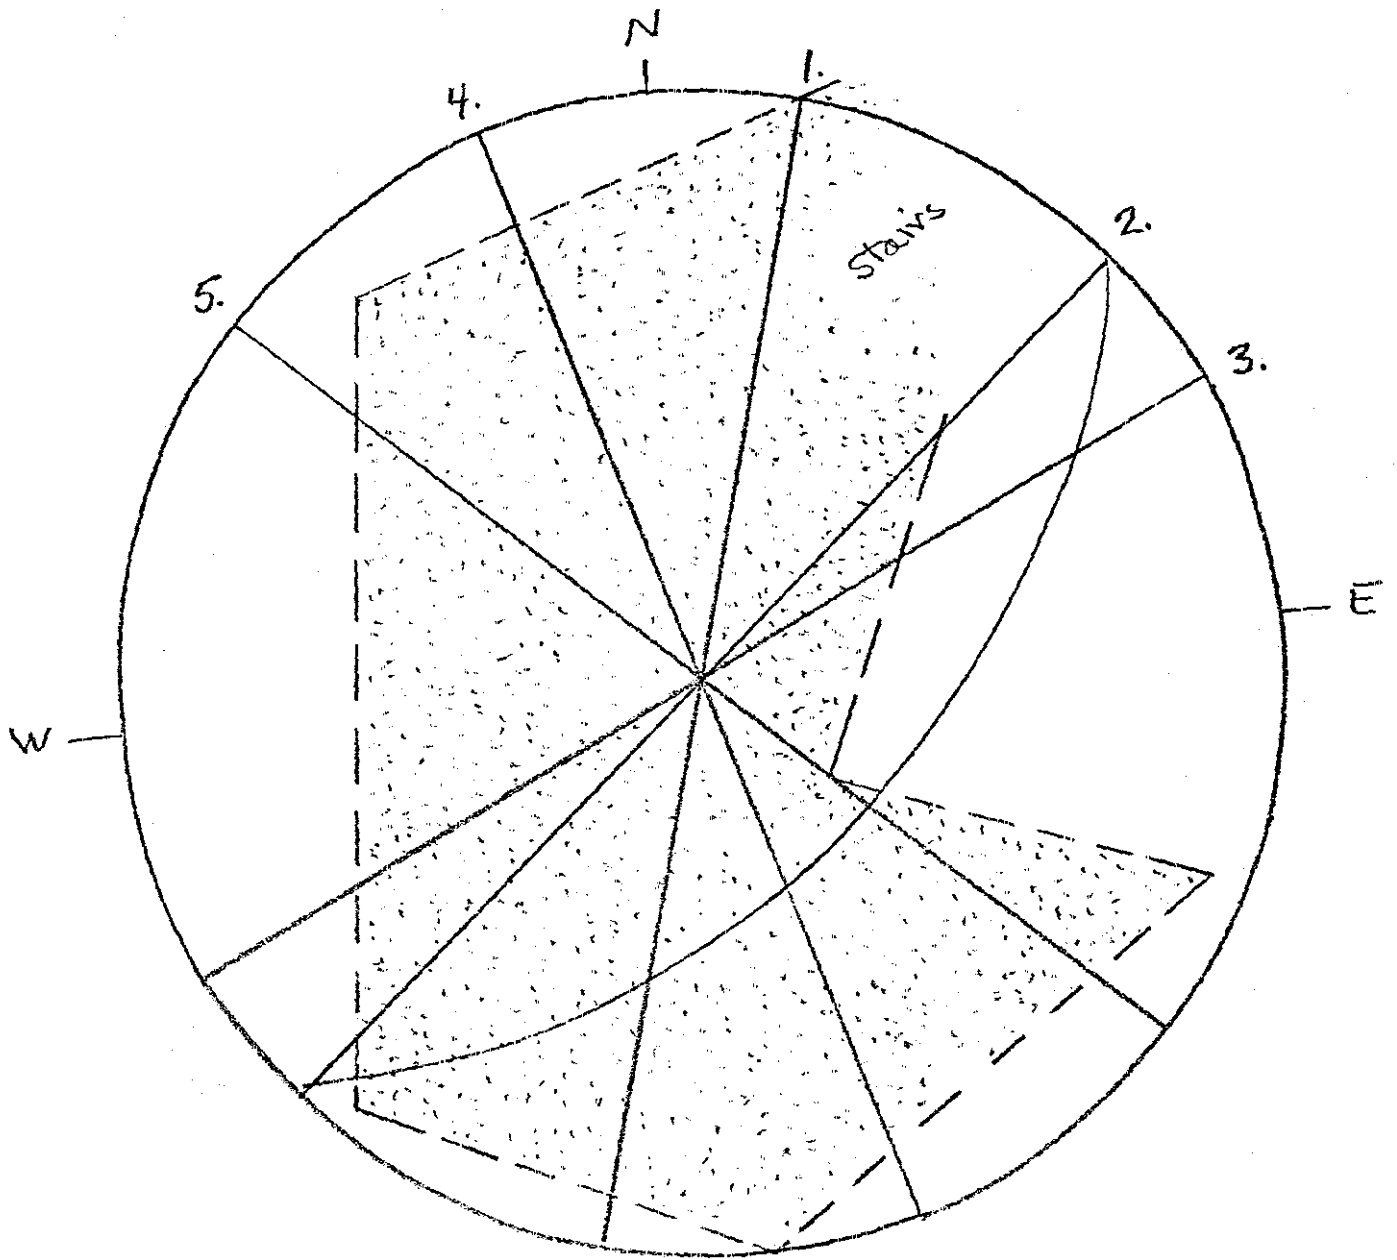
Figure 7.  
Fracture System Control of Platform Shape  
South Overlook

A close relationship exists between the present platform shapes, as defined by their railing orientations, and the generalized fracture sets shown in Table 1. (Fig. 7) Future failures can be anticipated to be governed by these same principal directions. Fissure development and extension will probably warn of the onset of dangerous weakening of the rock mass as gravity and weathering prepare the outer layer of the wall of the gorge for downslope movement by block falls or rock avalanches. Scars in the vegetation along the gorge walls show these processes are operating but the absence of large or deep scars and the near absence of talus buildup in the valley floor suggest that such failures are uncommon and/or affect only a few feet of the outer part of the slope surface.

Periodic inspection of the platforms and the slopes beneath should be made and pictures containing reference scales should be taken at intervals to provide a basis for slope stability change evaluation. Development of large numbers of small fissures sufficiently abundant to render the rock a loose brecciated mass and/or development of larger through-going fissures should both be examined for. Incorporation of sufficient reinforcing rods into any future platforms constructed would tend to create rigid land bridges capable of retaining their integrity even if unexpected rock avalanche activity developed along an outer part of one of the overlooks.
