WAUKESHA LIME AND STONE CO. FAULT

M.E. Ostrom

Open-File Report 61-1

June 26, 1961

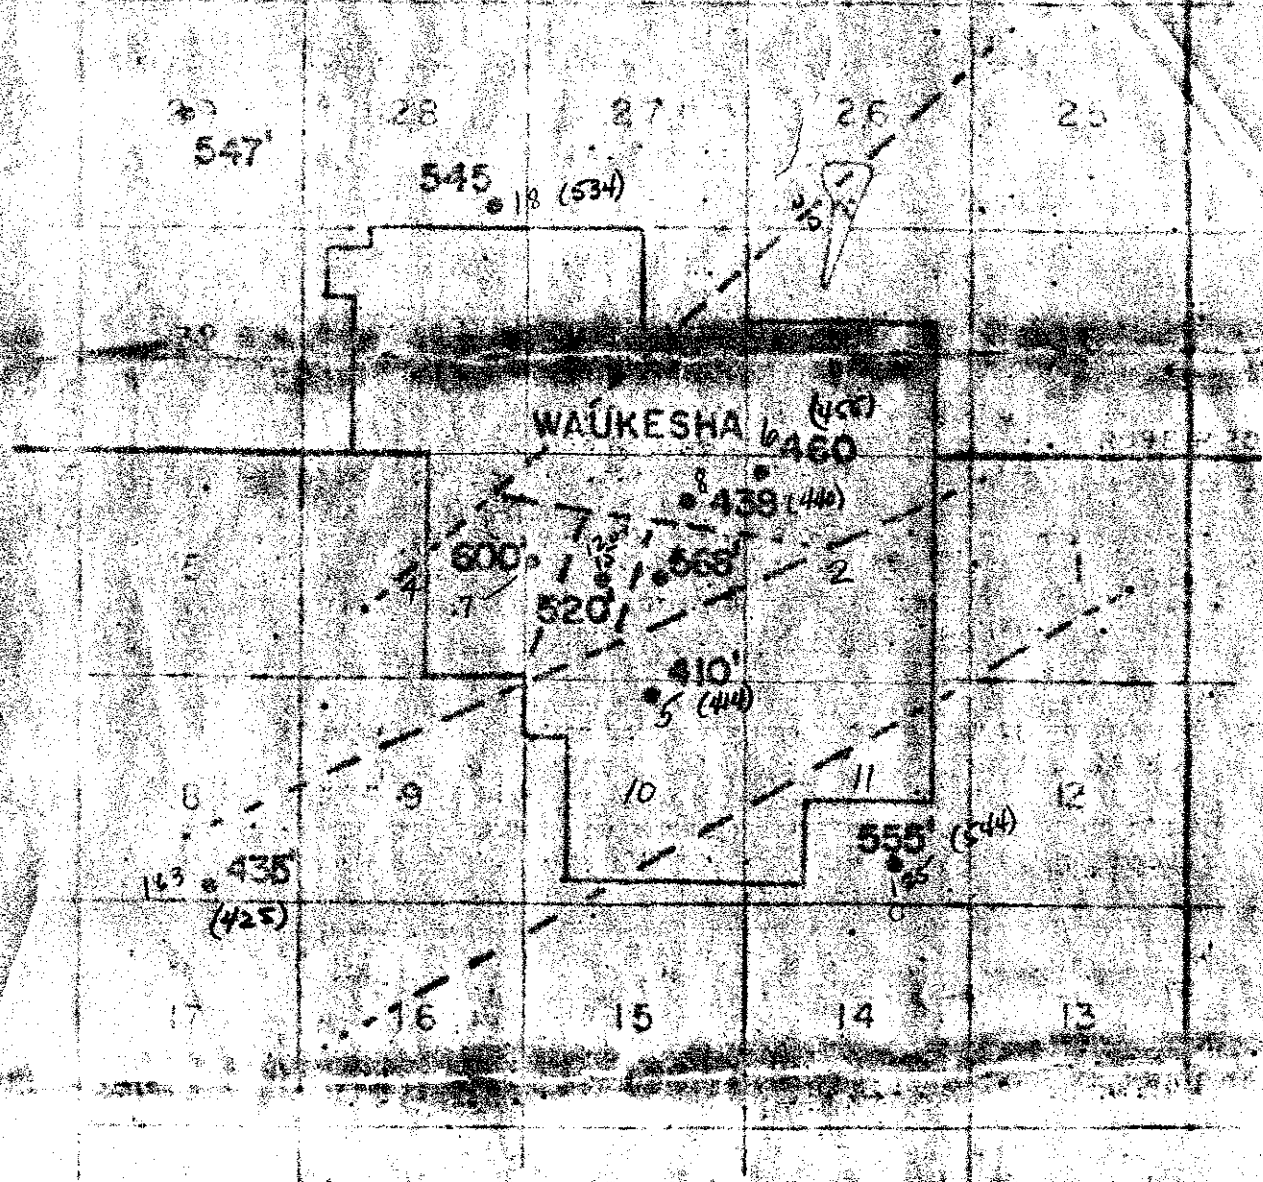
POSSIBLE FAULT ZONES IN WAUKESHA AREA BASED ON
VERTICAL DISPLACEMENT OF TOP OF GALENA DOLOMITE

On an attached sheet is a map indicating probable fault zones using the top of the Galena Dolomite Formation as reference datum and based on studies of water well samples in the files of the Wisconsin Geological and Natural History Survey. Although much more data is required before an accurate picture can be drawn, the data available indicate complex faulting of the area.

On the map all displacement indicated between any two wells is shown by a single fault. However, it is more likely that a series of en echelon step faults accounts for the total displacement. Thus, displacement along any one fault would be some amount less than the total displacement shown.
