# A GEOLOGICAL RECONNAISSANCE OF BENDER COUNTY PARK, MILWAUKEE COUNTY, WISCONSIN

## D.W. Hadley

Open-File Report 74-4 12 p.

1974

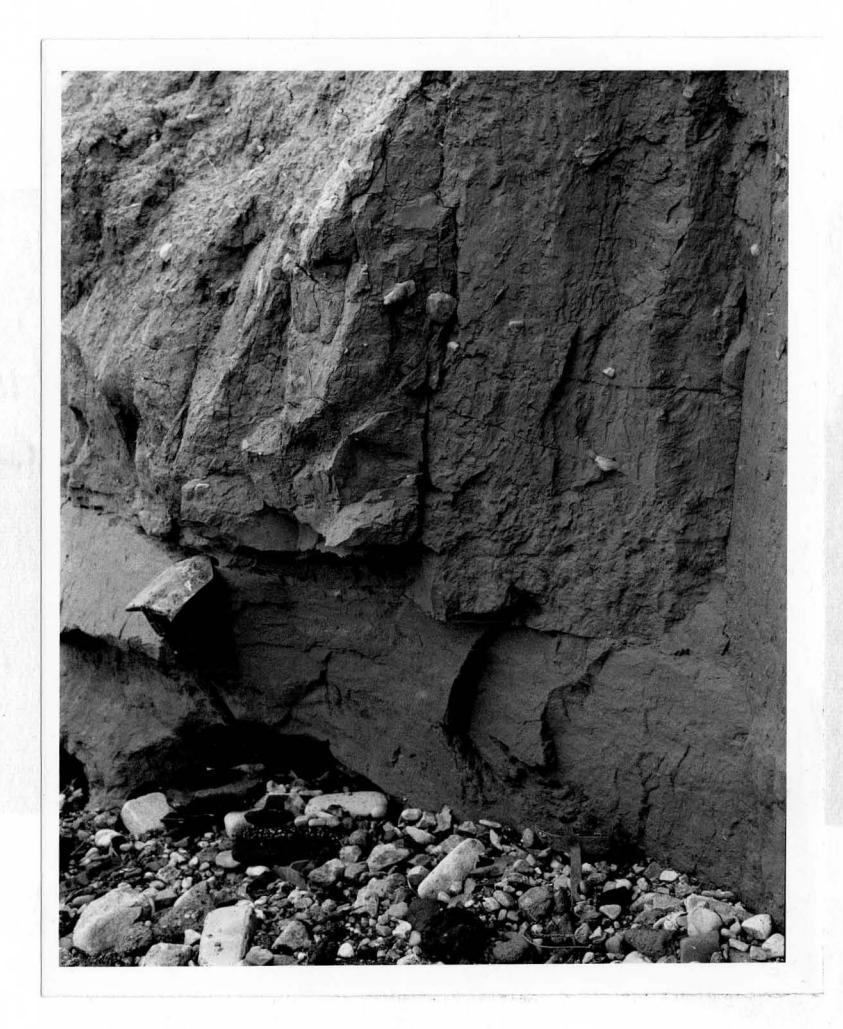
Figure 1 shows the contact between the silt and the overlying till. The point of the entrenching tool at the left edge of the photograph is at the contact. Notice the conspicuous vertical joints or cracks in the till unit, and also, the fact that these cracks do not carry through into the underlying silt.

Erosion is initiated by wave action at the base of the bluff. Waves undercut the overlying till, the vertical joints in the till near the exposed face open as tension cracks, and blocks of till drop to the base of the bluff and are removed through continuing wave action. This leads to the formation of nearly vertical cut faces such as that shown in Fig. 1.

As was shown on Fig. 1, the thick till unit that forms the bluff is underlain by a unit of clayey silt. In several spots, especially at the north end of the park, a line of springs was observed at the contact between the two units. It appears that water moves down the joint system in the till until it is blocked by the relatively impermeable clayey silt, and then moves laterally along the contact to the face of the bluff. As the result of the accumulation of water at the contact, a saturated zone has formed in both the upper portions of the silt and in the lower few inches of the till. This saturated zone appears to be the seat of most of the observed slumping. This is especially obvious in the area lying between Oakwood Road and the power plant. Here it can be seen that numerous slides have taken place, even though the base of the slope is relatively well protected from wave erosion by the wide beach that has accreted in this area.

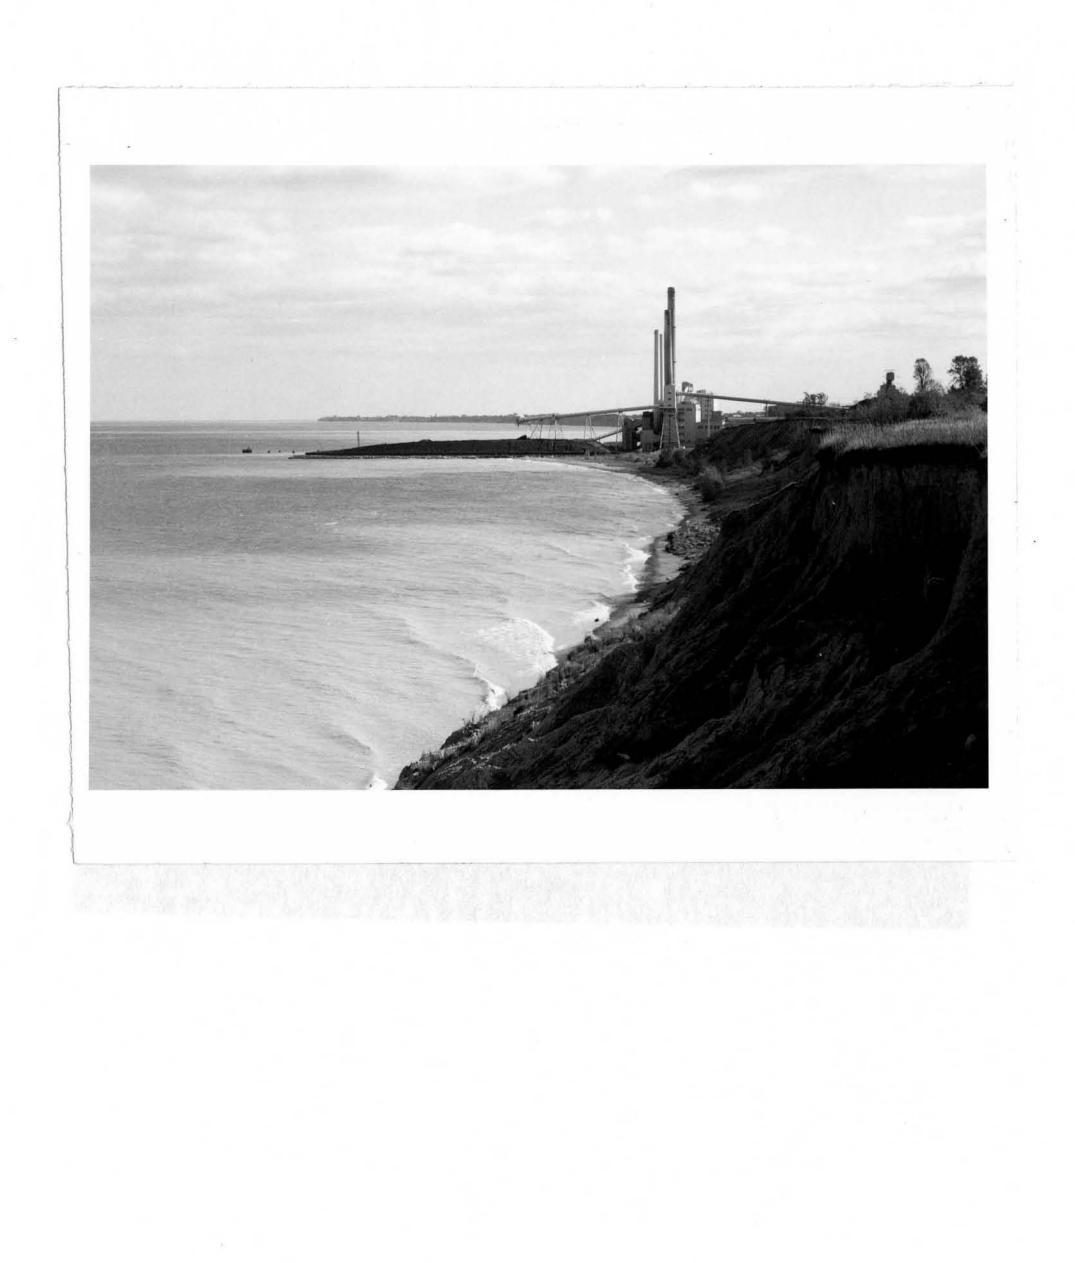
Figure 2 is a view from the top of the bluff near the southern end of the park looking south, and showing a large power plant extending out into the lake. The power plant has obstructed the southerly flow of sediments along the coast and as a result, a beach has formed. This beach extends from the power plant northward to a point almost directly below the spot from which this photograph was taken. Figure 3 is a view of the shoreline to the north of the plant, and was taken from the top of the bluff near the northern border of the park. Here again we see large structures jutting out into the lake and largely blocking the southerly flow of sediments. The lack of beaches in the area to the south of these structures is almost certainly due in large part to this interference with the natural movement of sediments along the shoreline. Figure 4 shows the foot of the bluff near the northern border of the park. Due to the absence of protective beaches, the waves are breaking directly against the base of the bluff.

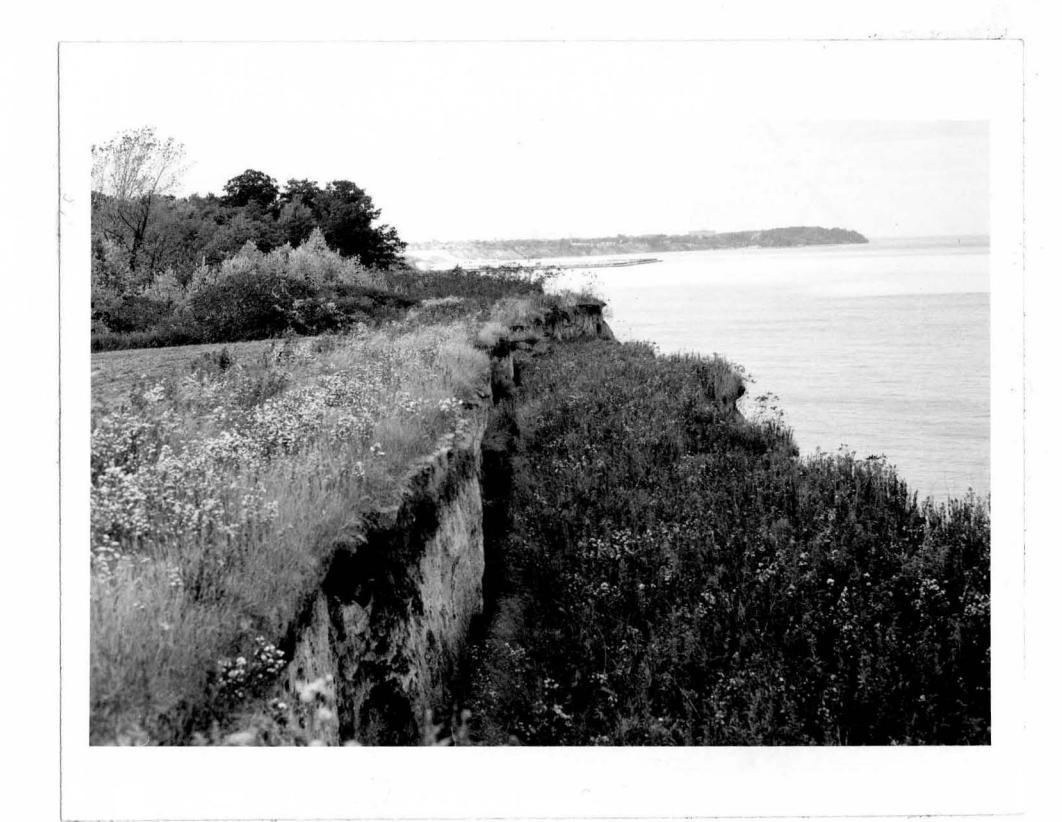
The first manifestation of slumping is often the appearance of an open crack at the head of the slump block, running roughly parallel to the trend of the bluff. An excellent example of such a crack is shown in Fig. 5. Movement of the slump block usually occurs in conjunction with major storms. This is probably due both to rapid erosion of the base of the slope by storm waves, and too the build up of pore water pressure in the soil due to the heavy rains. Figure 6 shows a slump block that has moved 10 to 15 feet downslope. The movement shown in this photograph has taken place along a continuation of the crack shown in Fig. 5. A composite view of the features described above is shown in Fig. 7. Notice the steep wave cut cliff at the water line, and the scarp at the top of the slope that shows the movement of extremely large slump blocks.
