Karst Feature and Spring Inventories

- **WGNHS Karst Features Inventory and related clippings for Pierce, Dunn and St. Croix Counties**
- **Wisconsin Conservation Department Spring Surveys**
 - [Dunn County](#)
 - [Pierce County](#)
 - [St. Croix County](#)

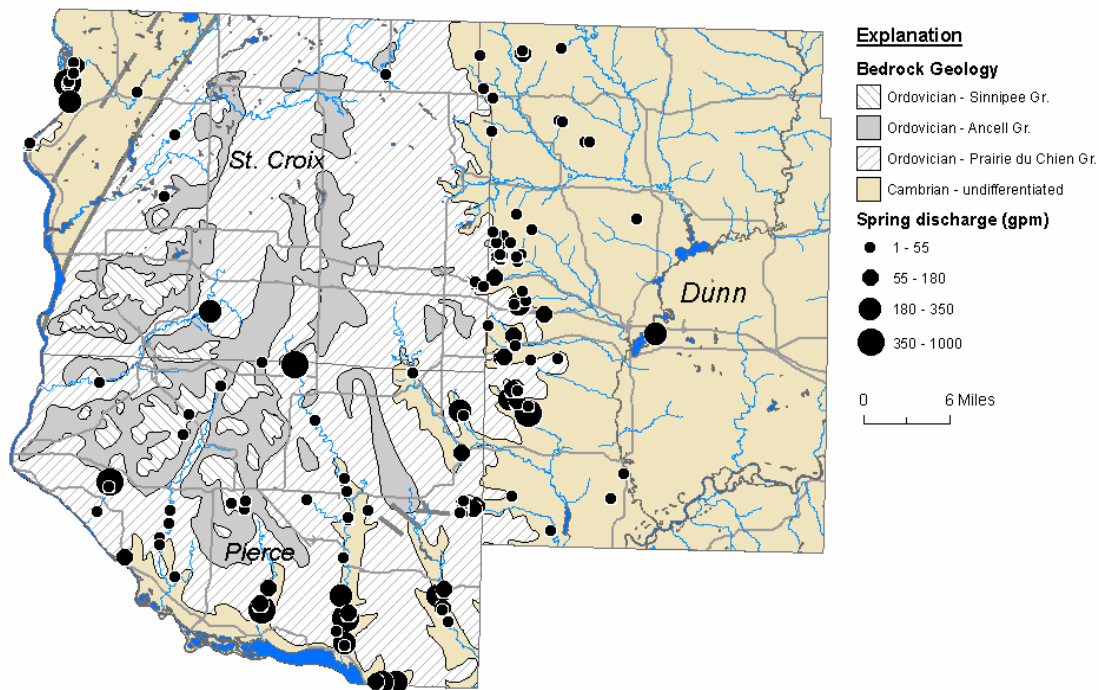
Distribution of springs with flow greater than 1 gpm in the project study area, as listed in Wisconsin Conservation Dept. (1959a, 1959b, 1960).

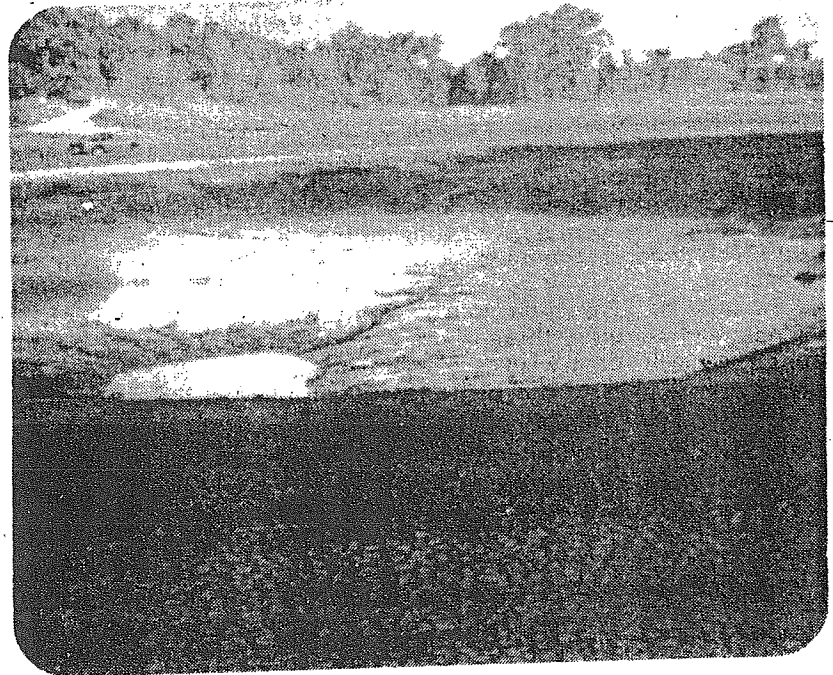
Pine Lake north of Baldwin has gone dry for the fourth time in the 20th century. A large sink hole opened up on the north end of the lake, just off the park, and drank a large part of Pine Lake dry.

The fluctuation of the lake is said to be due to the limestone bottom and consists of several sinkholes. It is a water table fed lake, and the drought of 1988 is probably as much a reason for the dry lake as the sinkholes.

Pine Lake north of Baldwin is dry...again!

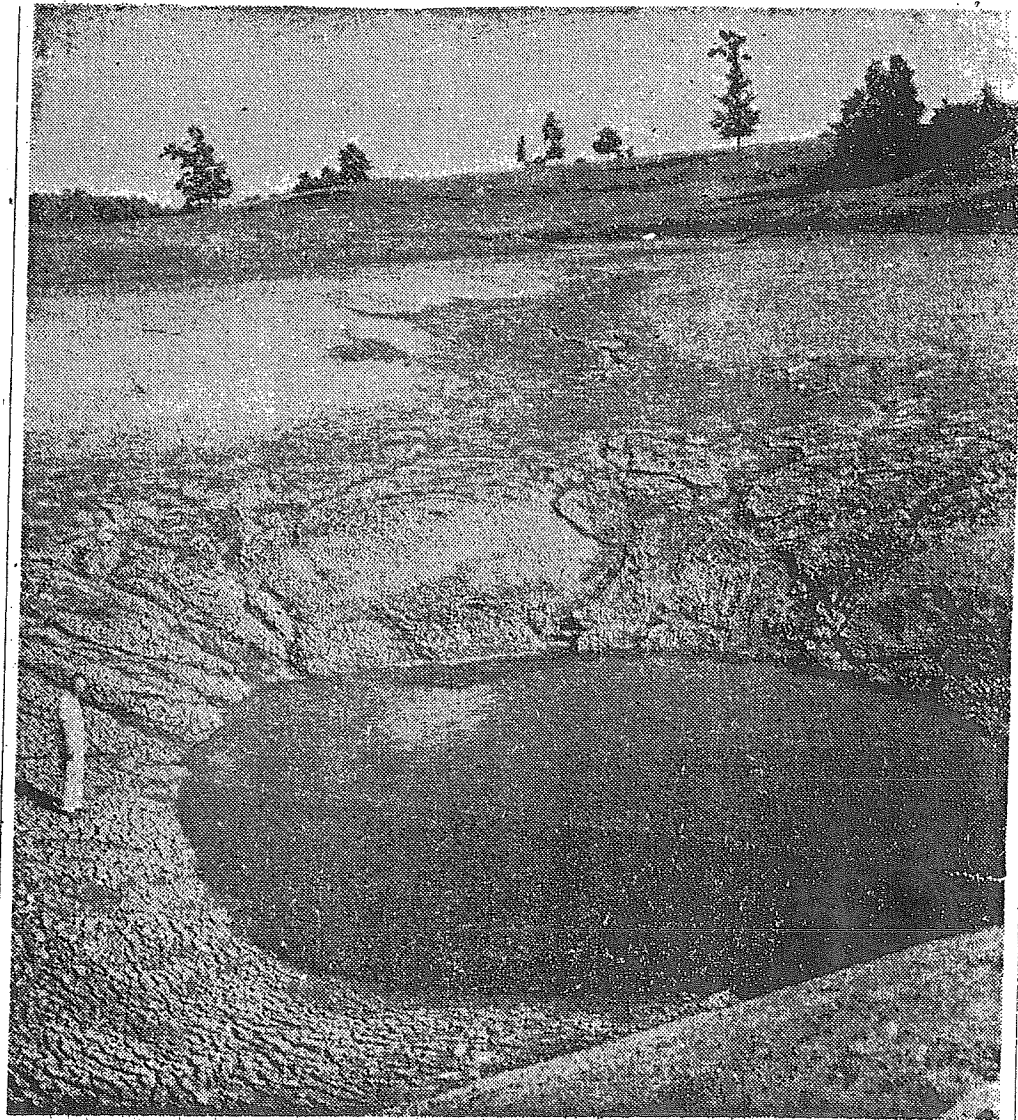
DISAPPEARANCE of a lake is graphically depicted in this photo of the dry lake bed and sink hole in Upper Pine lake, St. Croix county. Bottom of the sink is estimated at about 35 feet below maximum lake level. Gordon Frederic, Woodville, stands in left foreground.—Staff Photo.

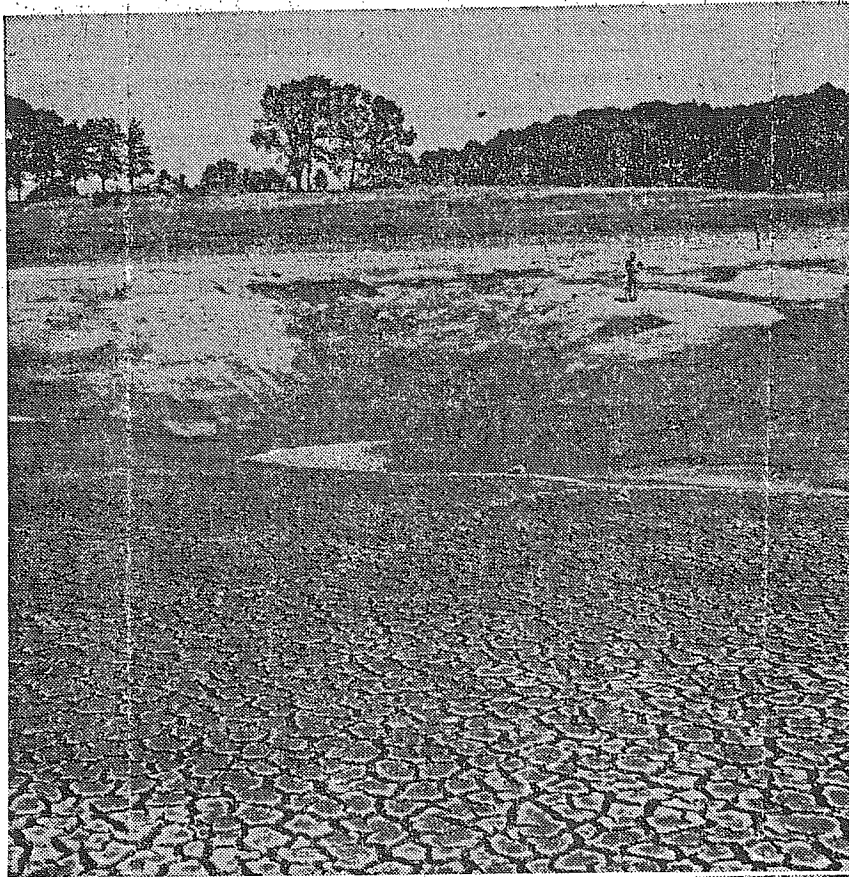
An example of what can be accomplished by determined sportsmen is illustrated in these pictures of Pine lake in St. Croix county. The upper photo shows the great sinkhole into which the lake had disappeared in 1959. Bert Apelgren, district fish biologist for the state conservation department, surveys the lake as it is today, 22 feet deep.

That was in the fall of 1959. By the following spring there was 10 feet of water in the lake, and in July the conservation department treated the water with toxaphene to kill any unwanted fish which had survived in shallow pools.

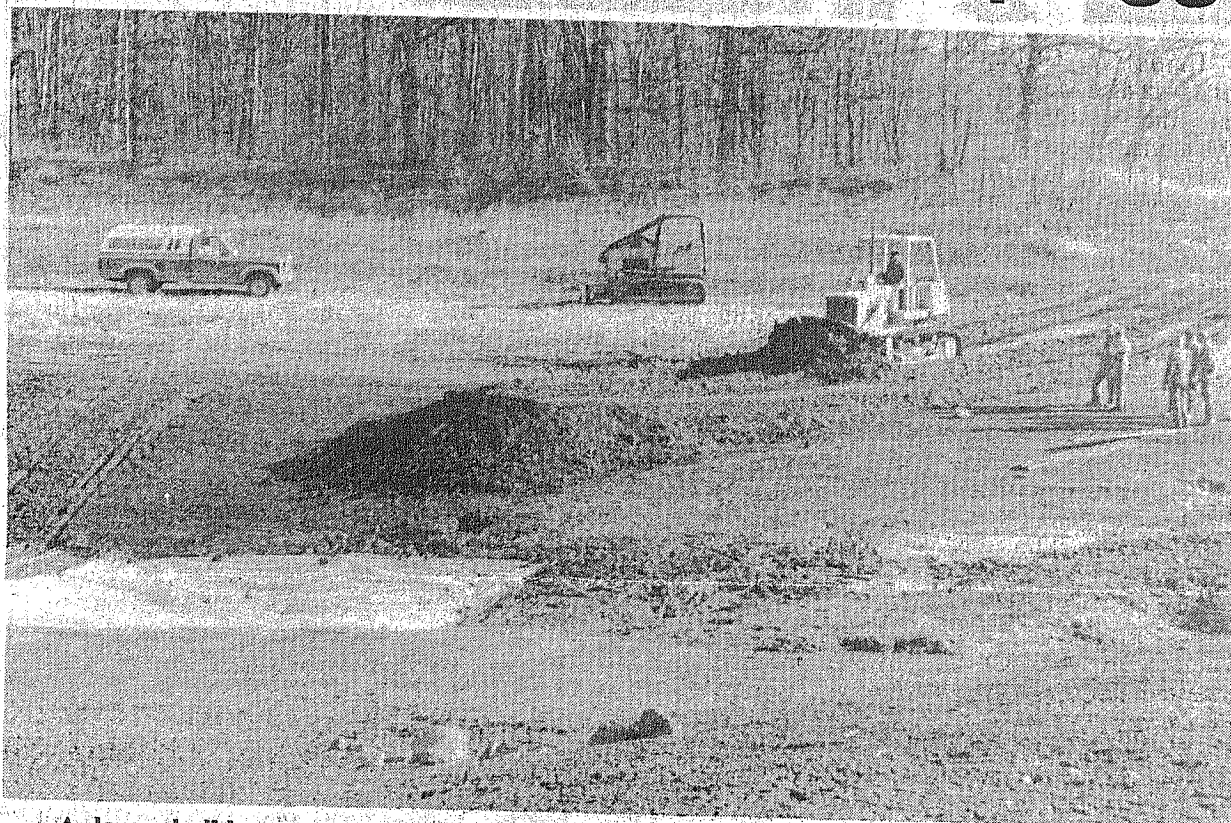
A large bulldozer operated by Bobby Jo Anderson of Anderson Excavating was used last Friday to move lake bed materials to fill the sinkhole at Pine Lake. The construction cloth that was placed over the sink hole area and covered with clay, gravel and sand is visible in the lower left of the photo.

The latest sinkhole to appear at Pine Lake was plugged last Friday with a layer of construction cloth and a mixture of clay, gravel and sand from the lake bed.

Engel said the preferred method of plugging the hole would have been to place rock under the construction cloth, but that was impossible because of the muddy conditions and lack of funds to haul rock to the site.

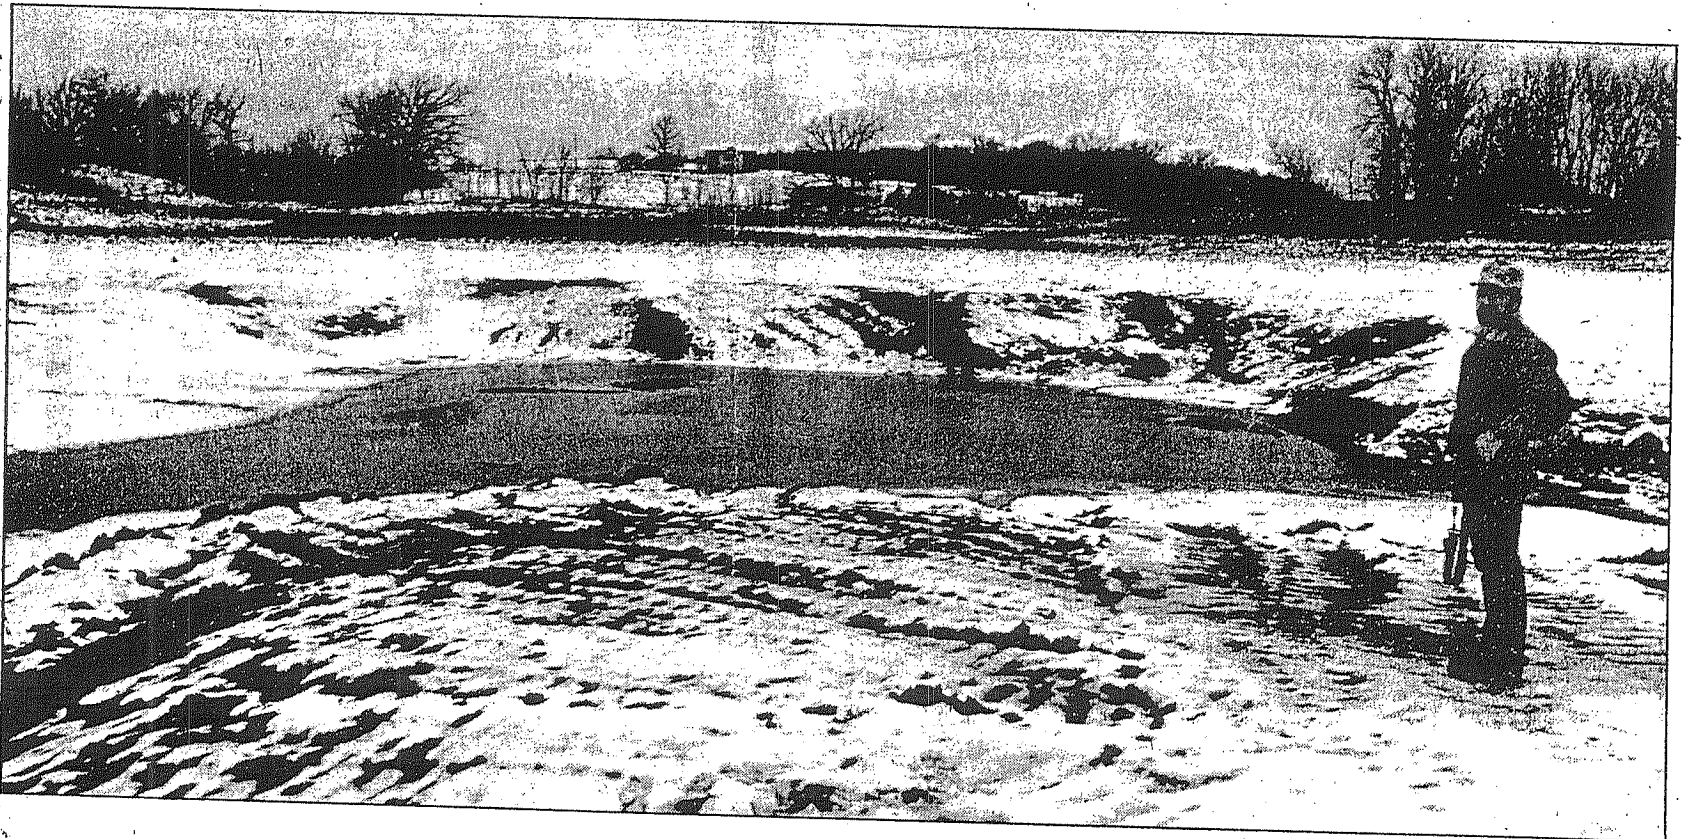
Marty Engel, a Department of Natural Resources fish manager based in Baldwin, stands on clay that was moved from the edge of Pine Lake and placed over a natural drain in a sinkhole. Pine Lake, located a few

miles north of Baldwin, is susceptible to periodic drainage because of sinkholes. The DNR and St. Croix County sportsmen's clubs are working to correct the problem.

The formation underlying the lake is susceptible to cracks that apparently caused this year's leak, according to Engel. The same area that drained this year had been patched in 1959. A different sinkhole was patched in 1985, Engel said.

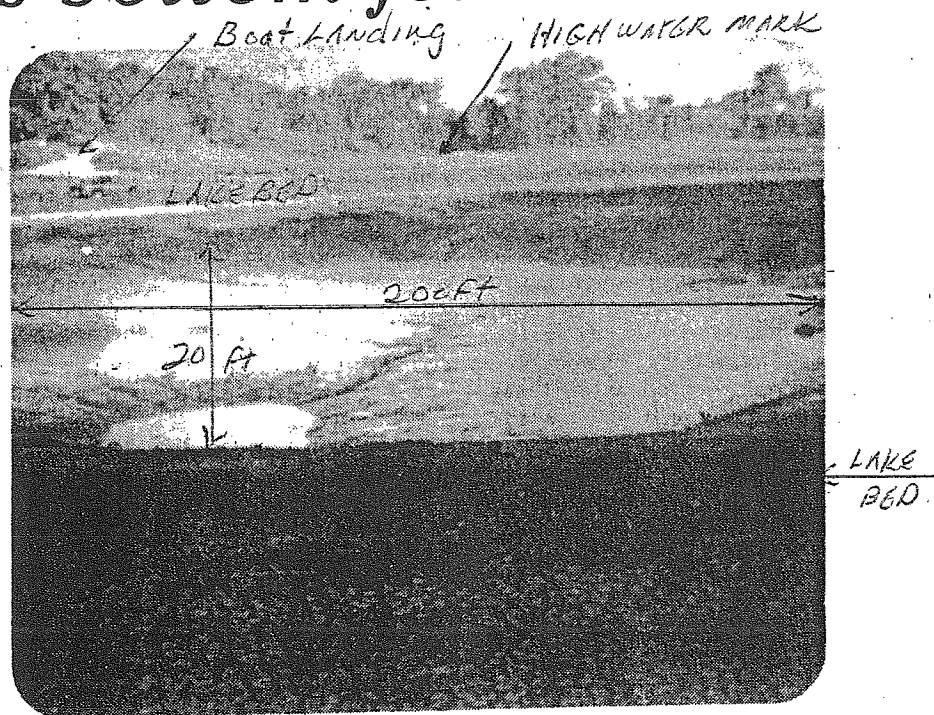
Pine Lake north of Baldwin is dry...again!

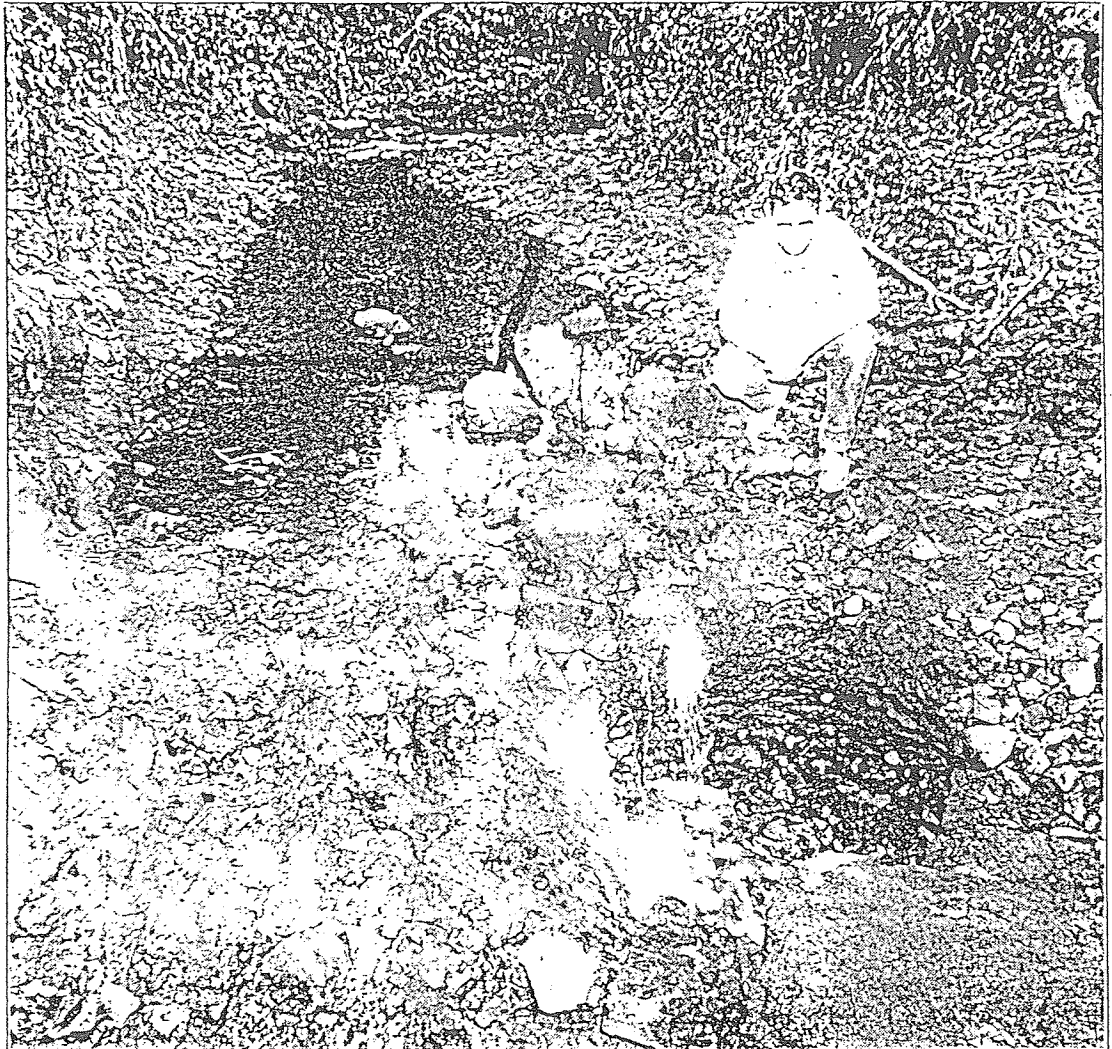
COUNTY RESOURCE AGENT ED HASS inspected the sinkhole in Isabelle Creek.

Hass said he walked downstream for nearly a half mile until the stream's flow resumed, fed by several small springs. In the stretch between, he found several places where water had ponded, but the bed was "bone dry" otherwise.

Finding sinkholes in streams isn't unusual because the water action slowly dissolves minerals and rocks over time, Collins explained. The slight acidity of rainwater causes fissured limestone bedrock to break down, enlarging any cracks, Hass said. As cracks in the "roof" of the cavern represented by the sinkhole grow, that covering is eventually undermined and collapses, he added.

Dye may be put in the sinkhole to trace the destination of its contents, Hass said. Sometimes efforts are made to plug these holes with concrete or a clay-like material to at least temporarily stop their groundwater impact, although he knew of no such project for this site. He thought a project to address the problem should be eligible for disaster funds like those authorized for this area by the federal government last week because of the storm.
