Special Report
Number 5

SHORELINE EROSION IN SOUTHEASTERN WISCONSIN

by
David W. Hadley
1976

University of Wisconsin-Extension
GEOLOGICAL AND NATURAL HISTORY SURVEY
M.E. Ostrom, State Geologist and Director
Madison, Wisconsin
February, 1976

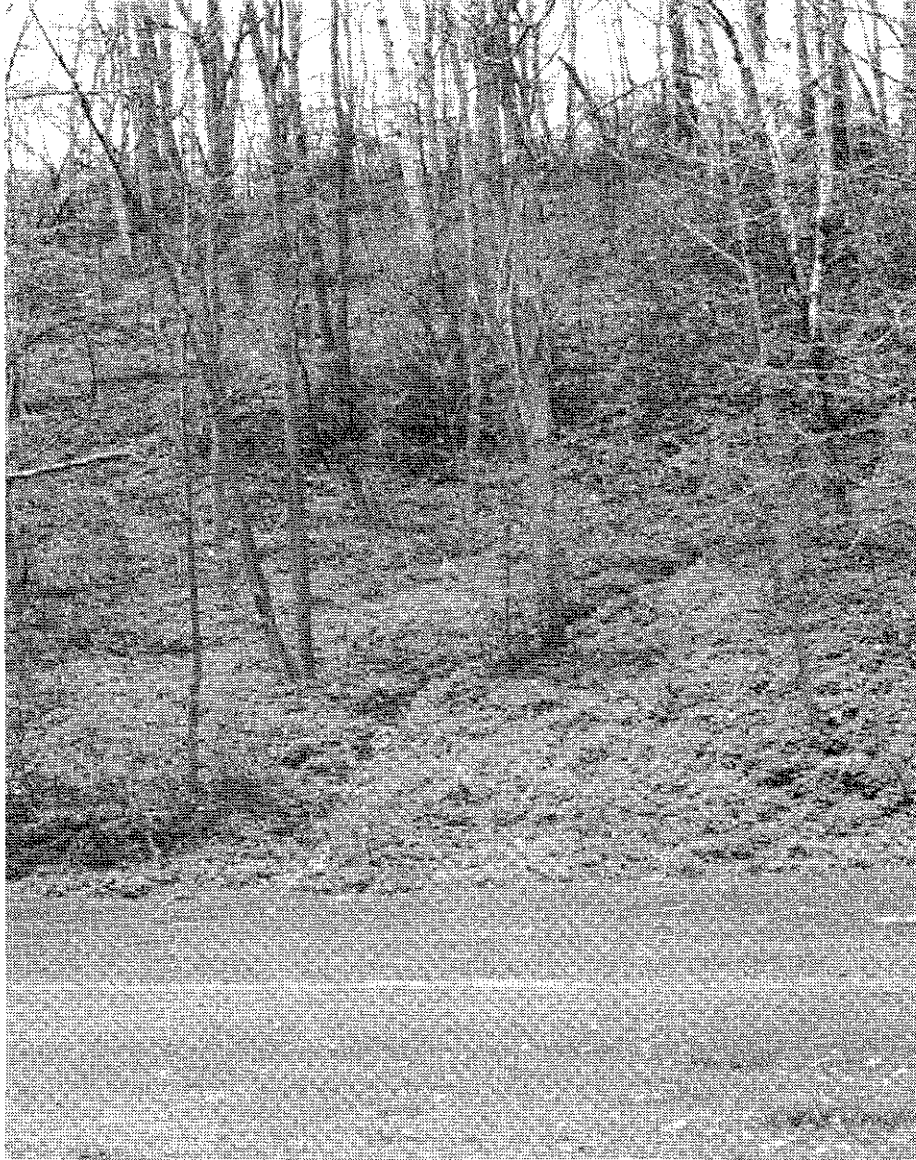
Figure 2. This terrace and low bluff were cut during glacial times when the lake was at a significantly higher level than it is today.

The very complex details of the evolution of the Great Lakes are beyond the scope of this report. Let it suffice to say that Lake Michigan drained either southward or eastward through a succession of outlets, that a new lake level was established with each successive outlet, and that along the shore line of each of these levels features were developed that are similar to those being formed today (Figure 2).

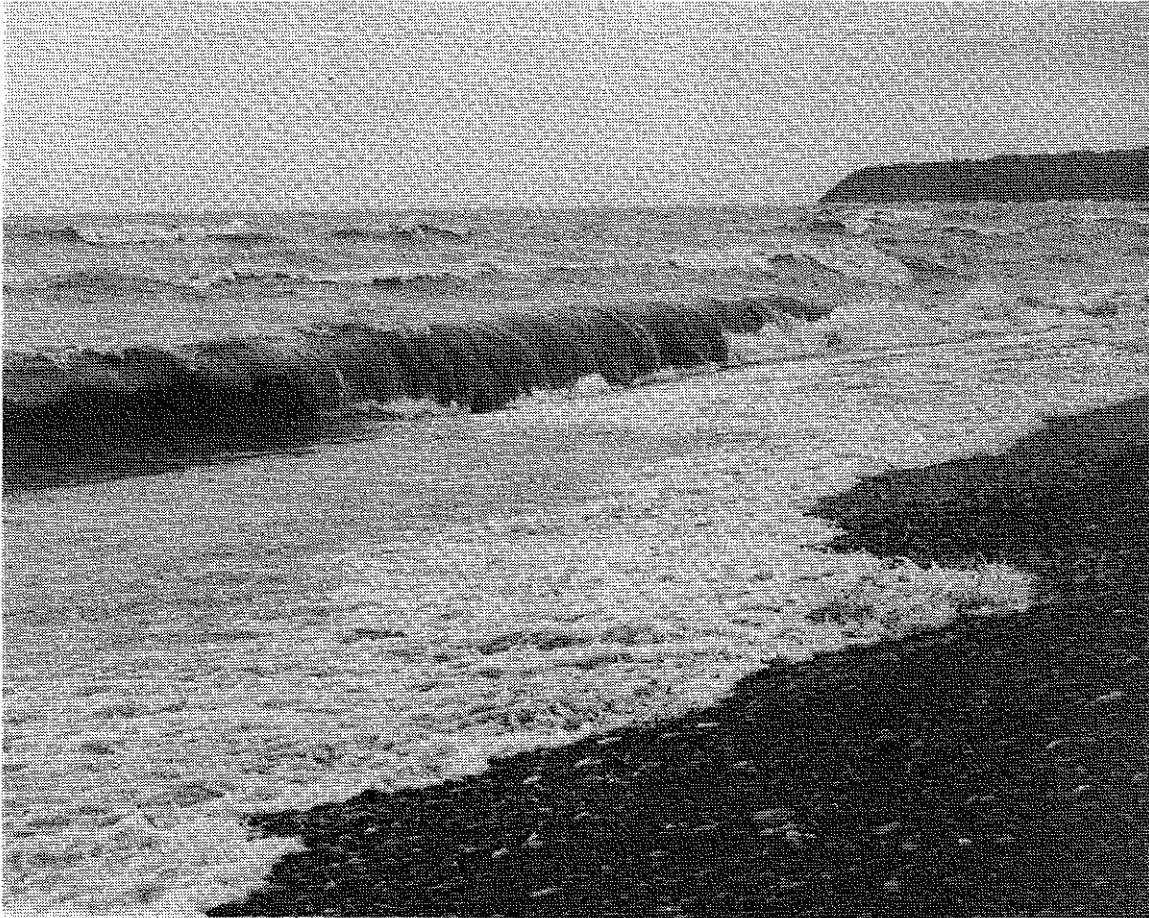
Figure 3. As waves interact with the bottom, they become more closely spaced, increase in height, and eventually fall forward and break against the beach. Notice the pebbles being moved along the beach by the uprushing water.

The picture changes rapidly, however, when waves near the shore and enter progressively shallower water. As this occurs, waves begin to interact with the bottom, their speed decreases, and they become more closely spaced. As waves move into progressively shallower water, they begin to increase in height and to tilt forward toward the shore. Eventually, they become unstable and fall forward, or break (Figure 3).

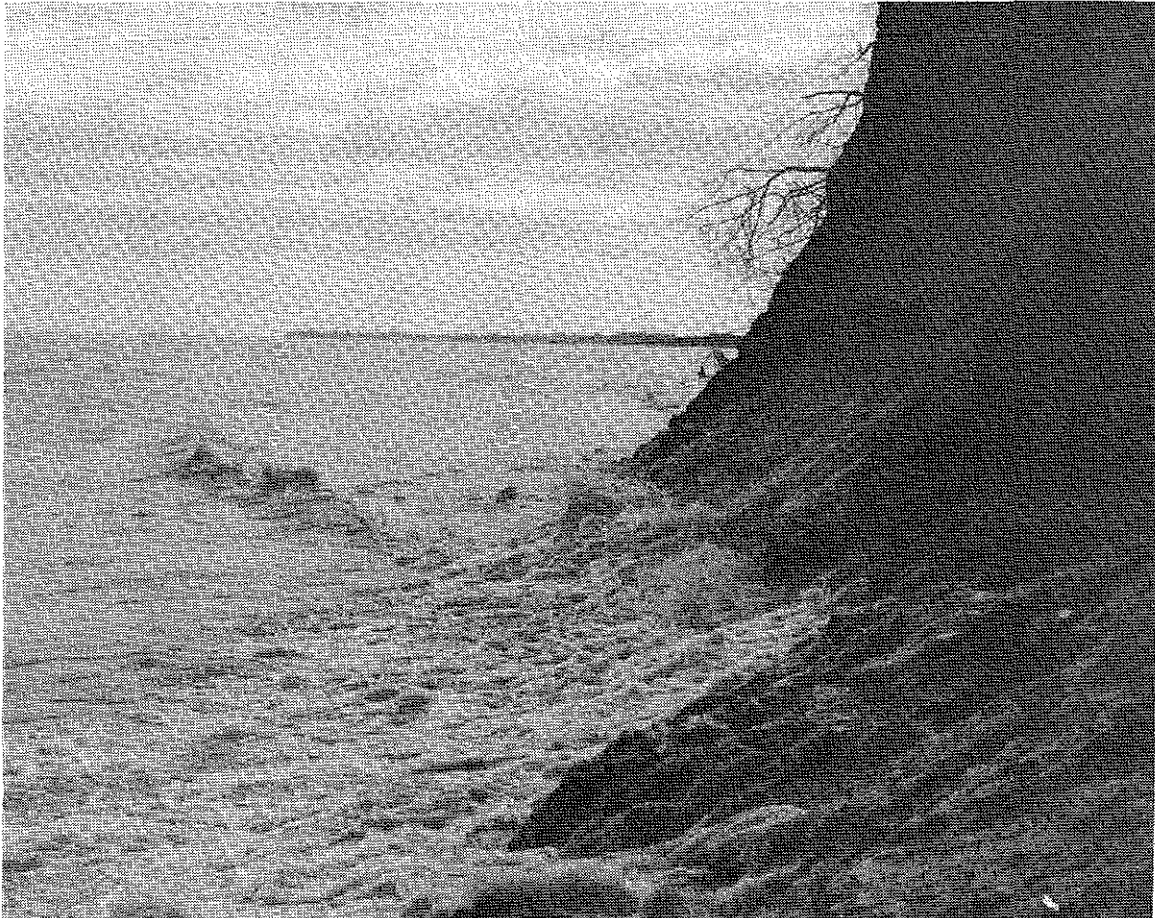
Figure 6. During periods of high lake levels the beaches may be submerged, leading to rapid erosion at the base of the bluffs.

With low water levels, the brunt of the force of storm waves is taken by the beaches. When the water levels are high, however, the beaches are partially or wholly submerged and storm waves break close to and in some cases directly against the bluffs (Figure 6). This brings about the rapid erosion of the poorly consolidated materials exposed along the foot of the bluffs. As a result the base of the bluffs is undercut, the bluffs become oversteepened and unstable, and massive slope failures along the bluffs may follow.

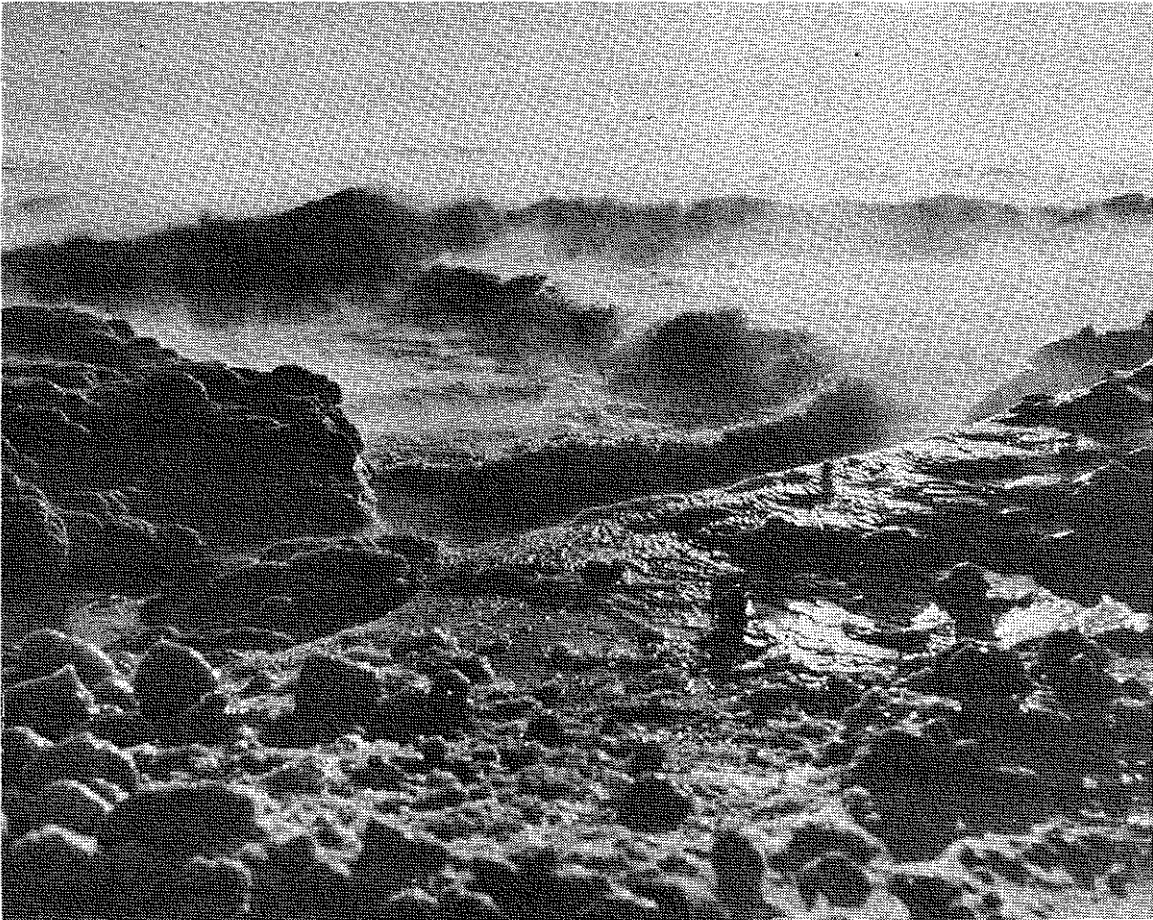
Figure 7. Ice protects the shoreline from erosion by winter storm waves. Wind-driven free-floating ice can, however, do extensive damage. (Milwaukee Journal Photo)

During a normal winter season, substantial ice develops along the shore of Lake Michigan. For the most part this is beneficial, since the ice serves as a protective barrier against winter storm waves (Figure 7).

Once the ice begins to break up, however, the picture can change rapidly. Masses of free ice, driven by strong winds and storm waves, can cause extensive scour of the lake bottom and damage to structures along the lakeshore.

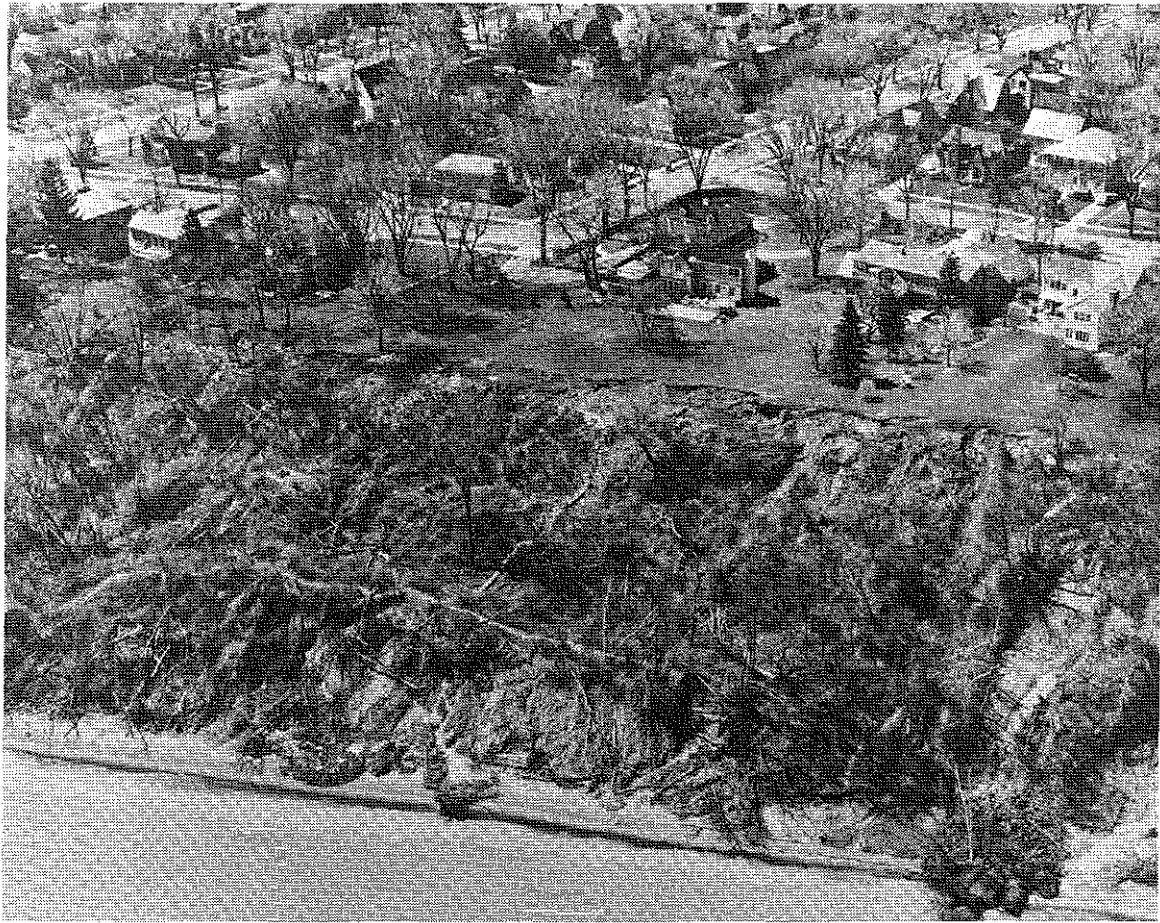
Figure 9. Continuing erosion at the toe of the bluff has caused a series of slumps to occur along this section of the shoreline. (Milwaukee Journal Photo)

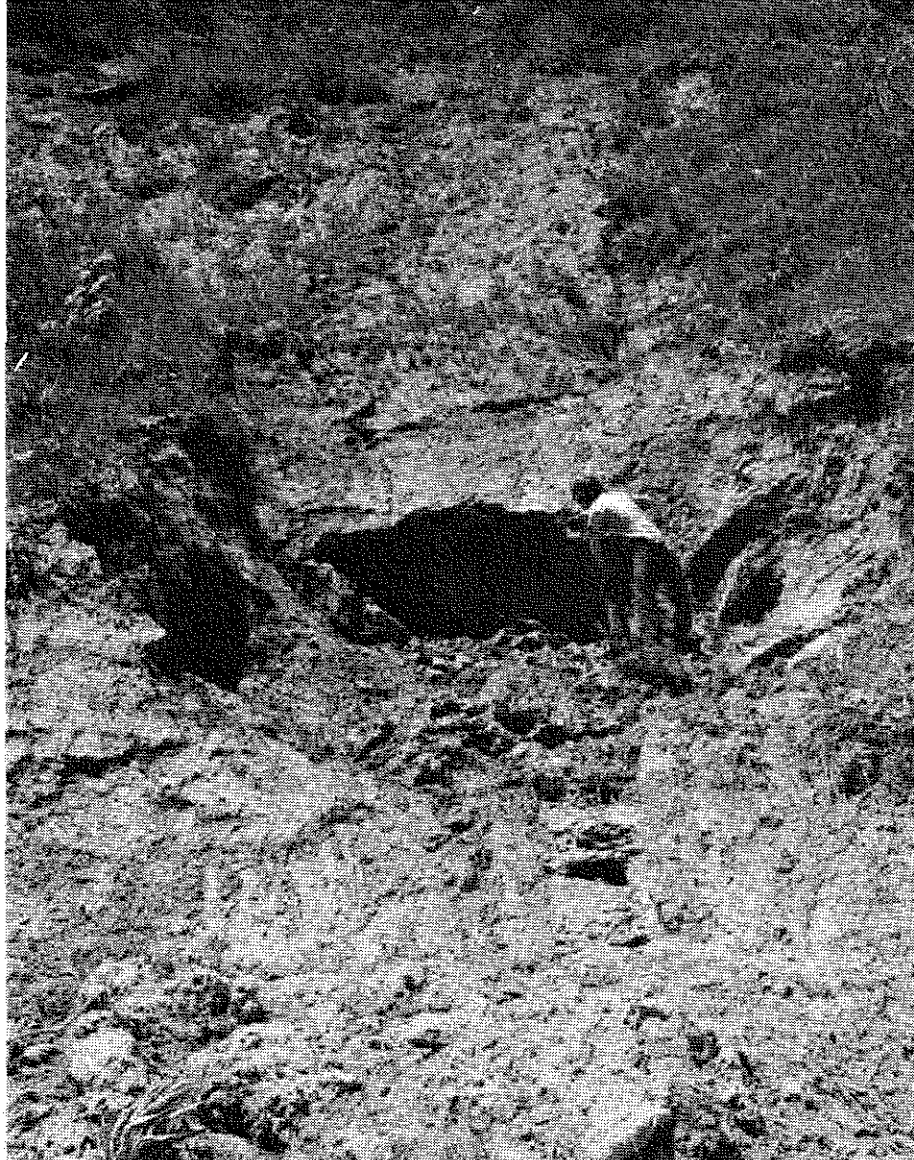
Figure 10. Springs such as this form where the groundwater moving downward through the bluffs encounters a zone of low permeability. Groundwater seepage plays an important role in the retreat of the bluffs along much of the Lake Michigan shoreline in southeastern Wisconsin.

Although damp sand and sandy silt are able to maintain a steep slope, these materials have very little strength when they are saturated. The saturated sands and silts associated with the springs along the bluffs are often unable to hold the steep slope of the bluffs, and consequently numerous small failures occur (Figure 10).

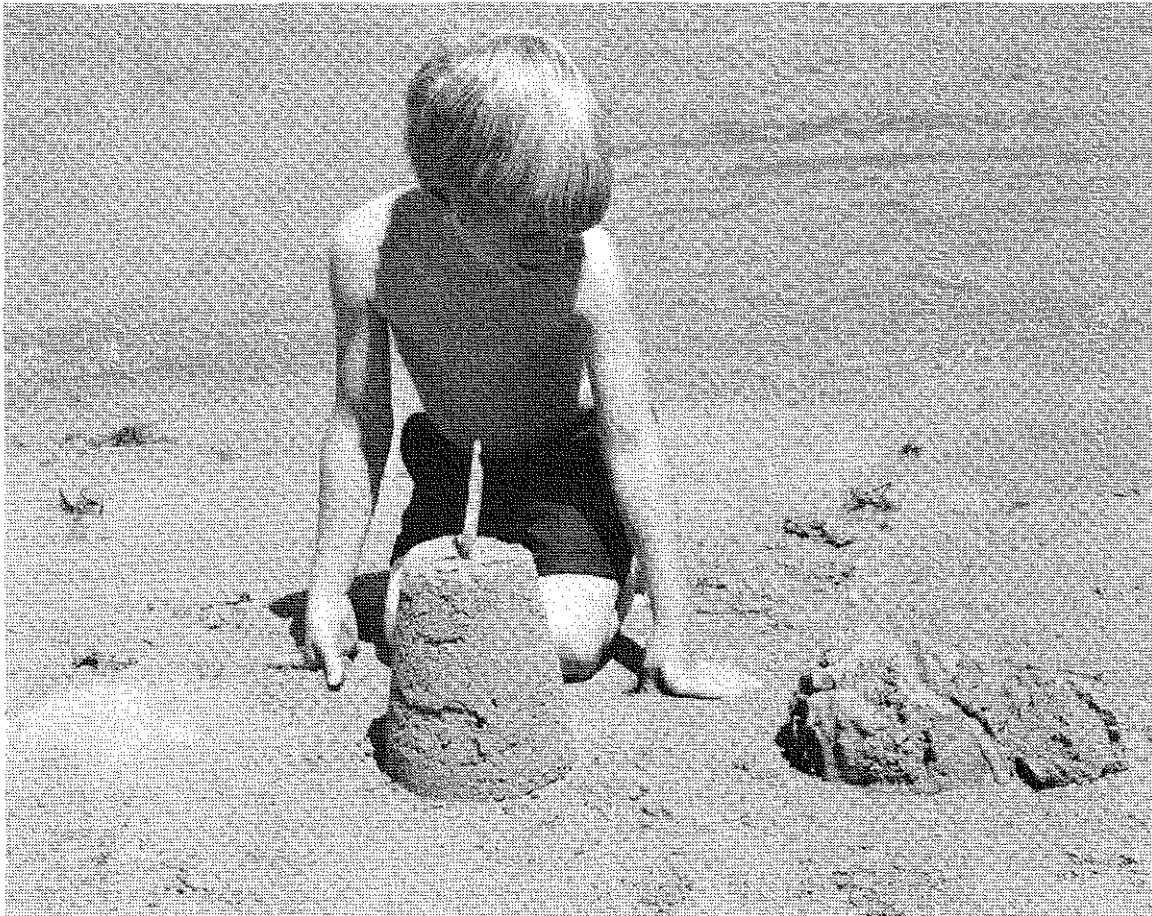
Figure 11. All experienced sand-castle builders know that although moist sand will maintain a steep slope, failure will result when the sand dries (left) or becomes saturated (right).

In areas in which the vegetation has been removed from the bluffs by slumping, the exposed materials dry out rapidly. Dry sand has very little strength, and on steep slopes, the surfaces of exposed sand beds will slowly trickle away as the sand dries. This also leads to the undermining, or sapping, of the overlying beds and can lead to further slope failures (Figure 11).

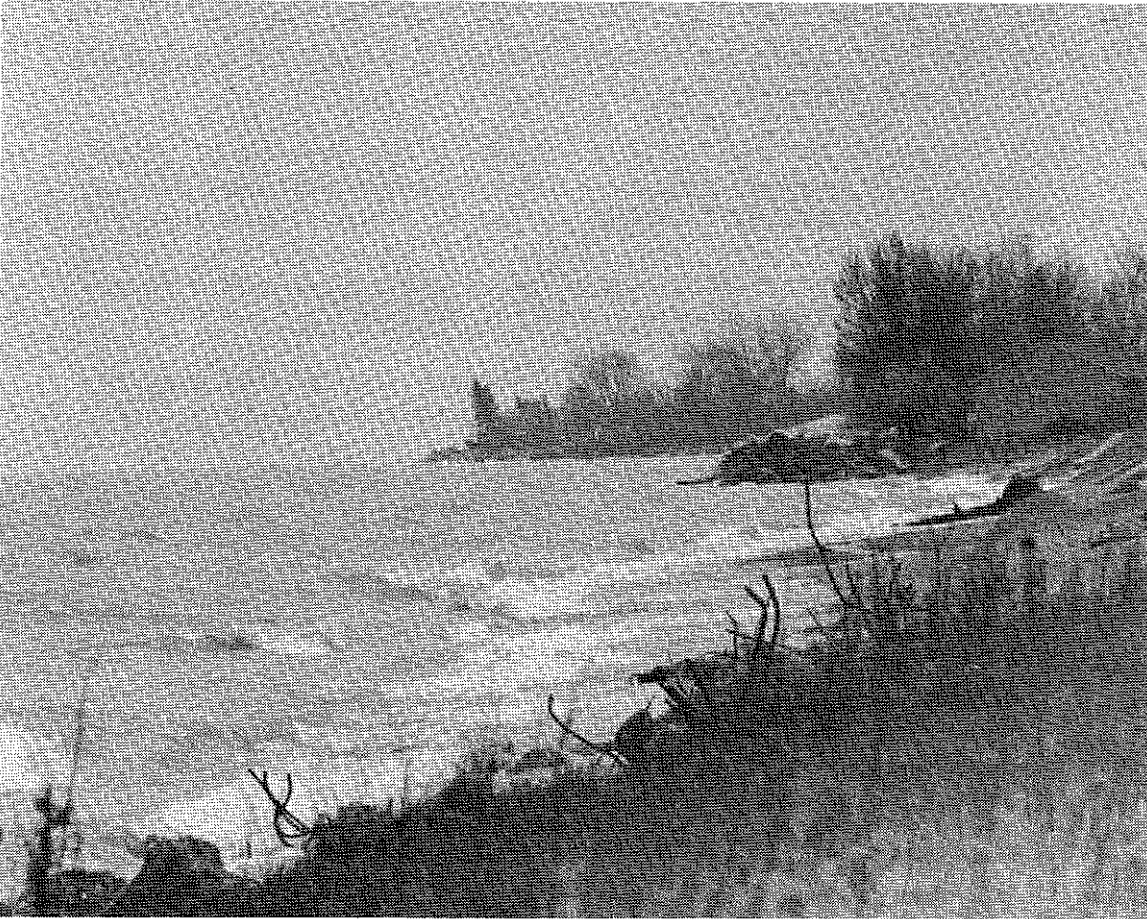
Figure 12. Although these homes are protected by stone revetments, the unprotected adjacent shoreline has been rapidly eroded. The exposed flanks of the properties now must also be protected.

It has been found that very few attempts by individual property owners to protect isolated property are successful. This is primarily due to the fact that the erosion of surrounding unprotected sections of the coast soon exposes the sides of the protective structures, leading to rapid failure (Figure 12). Every effort should be made, therefore, to attack the problem of shoreline erosion on a community rather than an individual basis. If the property owners along a segment of the shore pool their resources, chances of building a successful structure will be greatly improved and the cost to individual property owners will likely be substantially reduced.

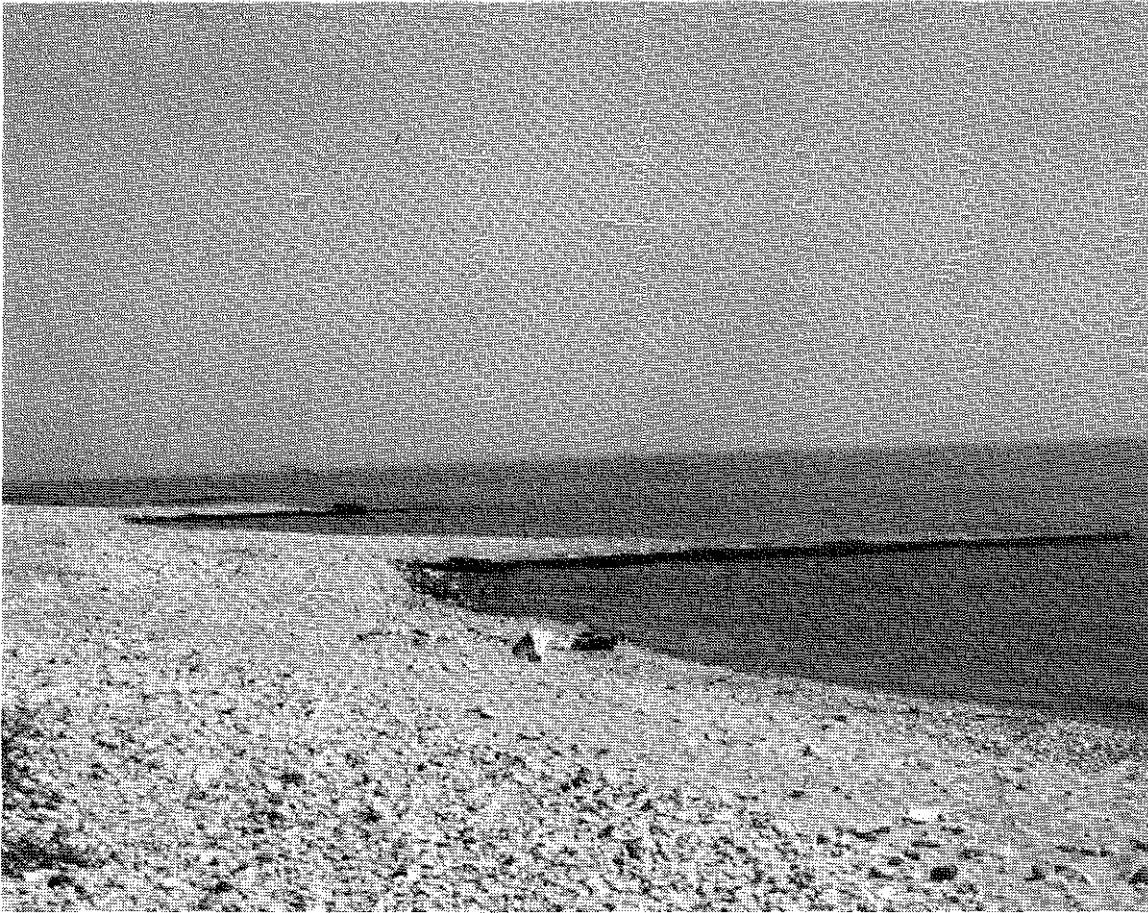
Figure 13. Groins interrupt the flow of sand being carried along the shoreline by the littoral drift. The resulting beach protects the shoreline.

Groins are structures built out from the beach in order to block the flow of the littoral drift and cause the buildup of sand behind them.

Groins are not recommended for use in most of southeastern Wisconsin. There are three major factors that argue against their use. First, a great deal of information about the waves, wind, bottom conditions, and currents in the lake is necessary for the design of a successful groin. In addition since relatively little sand is supplied to the shoreline through erosion, even a well-designed groin might not form and hold a beach without the periodic addition of large amounts of sand from an outside source. Finally, blocking the littoral drift would almost certainly result in greatly increased erosion of the shoreline located down drift, raising the possibility of legal problems (Figures 13 and 14).

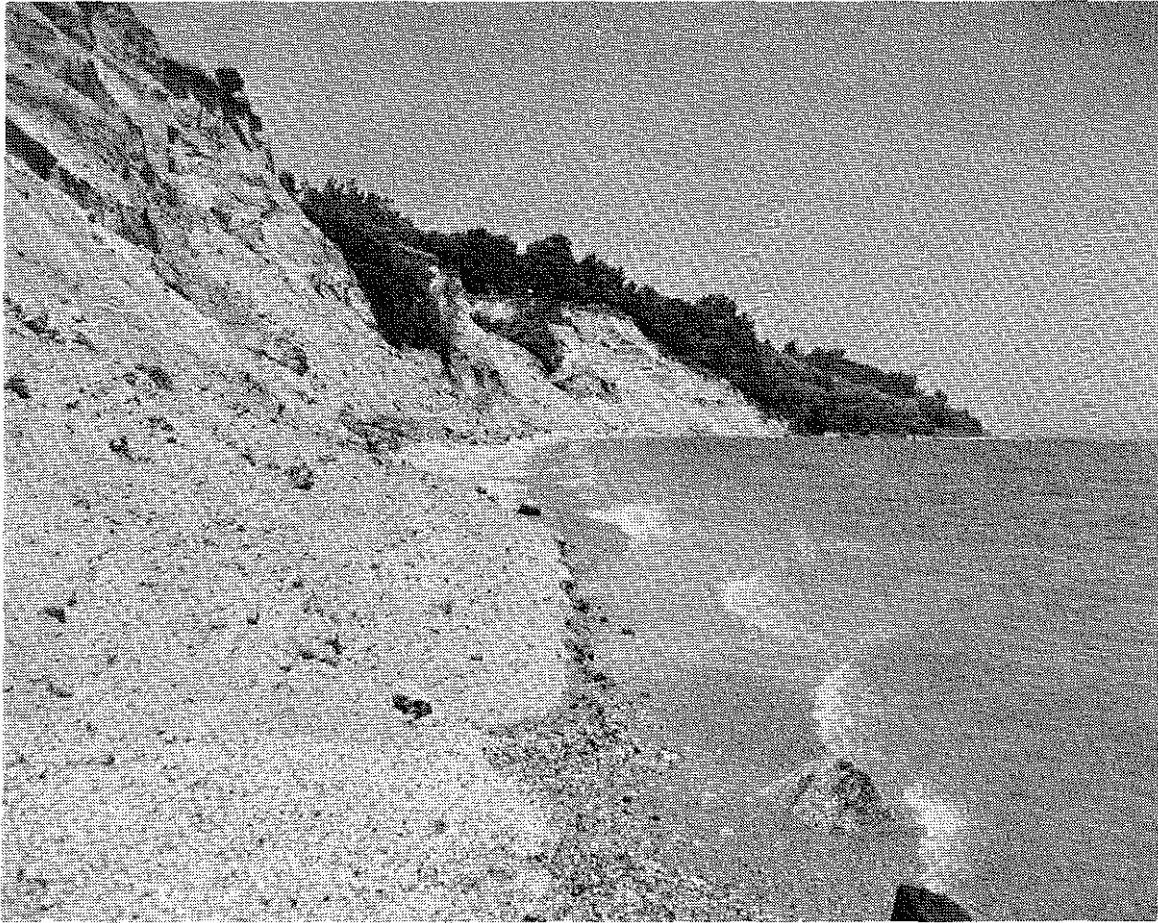
Figure 14. The section of shoreline in the background has been protected by the groins shown in Figure 13. By interrupting the flow of sand along the shore, however, these groins have also contributed to the accelerated erosion of the shoreline shown in the foreground.

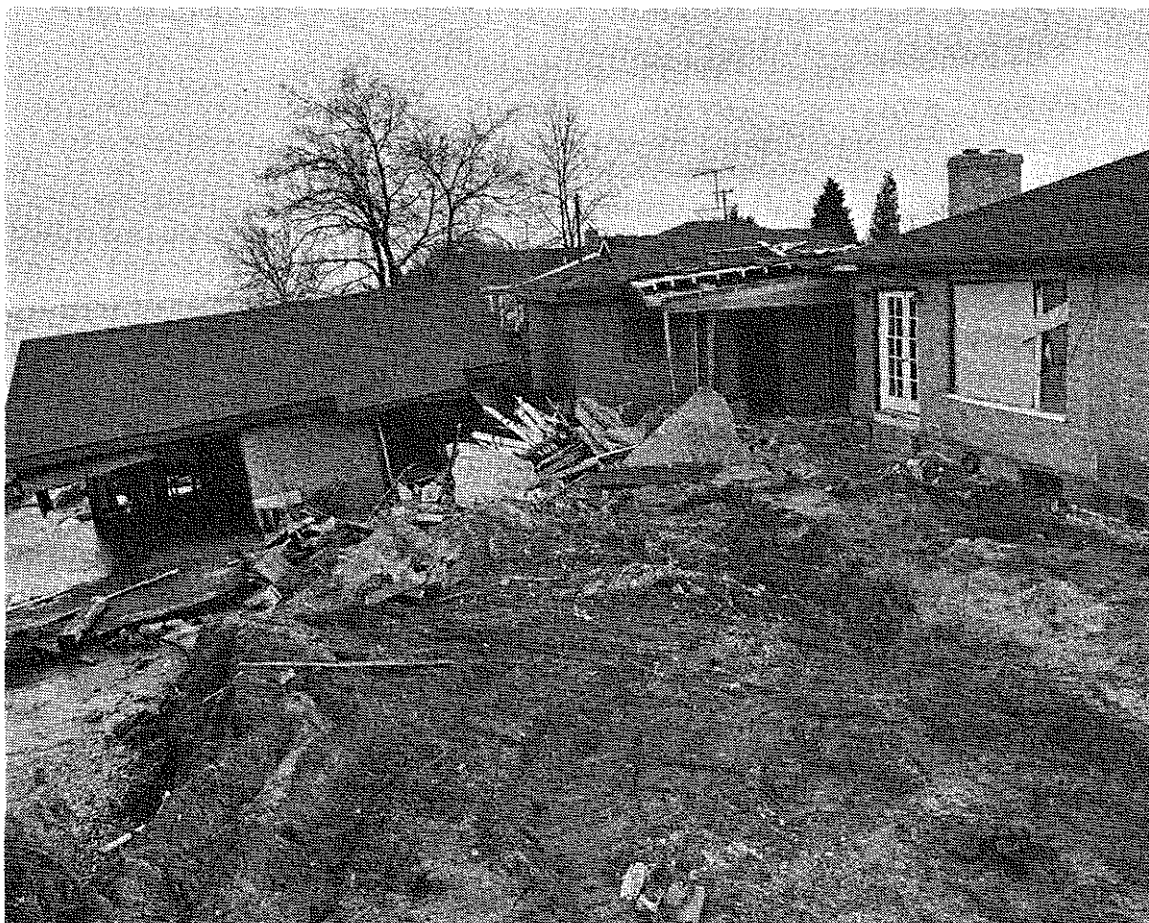
Figure 16. Attempts to protect this residence have obviously been unsuccessful. (Milwaukee Journal Photo)

d. The Effectiveness of Protective Structures. As a part of the investigation upon which this report is based, I inspected much of the shoreline of Lake Michigan from the Illinois-Wisconsin state line to the northern border of Ozaukee County. In the course of this inspection, I found that the lake shore was strewn with the remains of supposedly permanent protective structures. Some of these structures likely failed as the result of poor design and some because of poor construction. Some were, no doubt, the victims of scour by wind-driven ice. Regardless of the cause of failure, however, most efforts to control shoreline erosion in the area have been ineffective and short-lived (Figures 15 and 16).

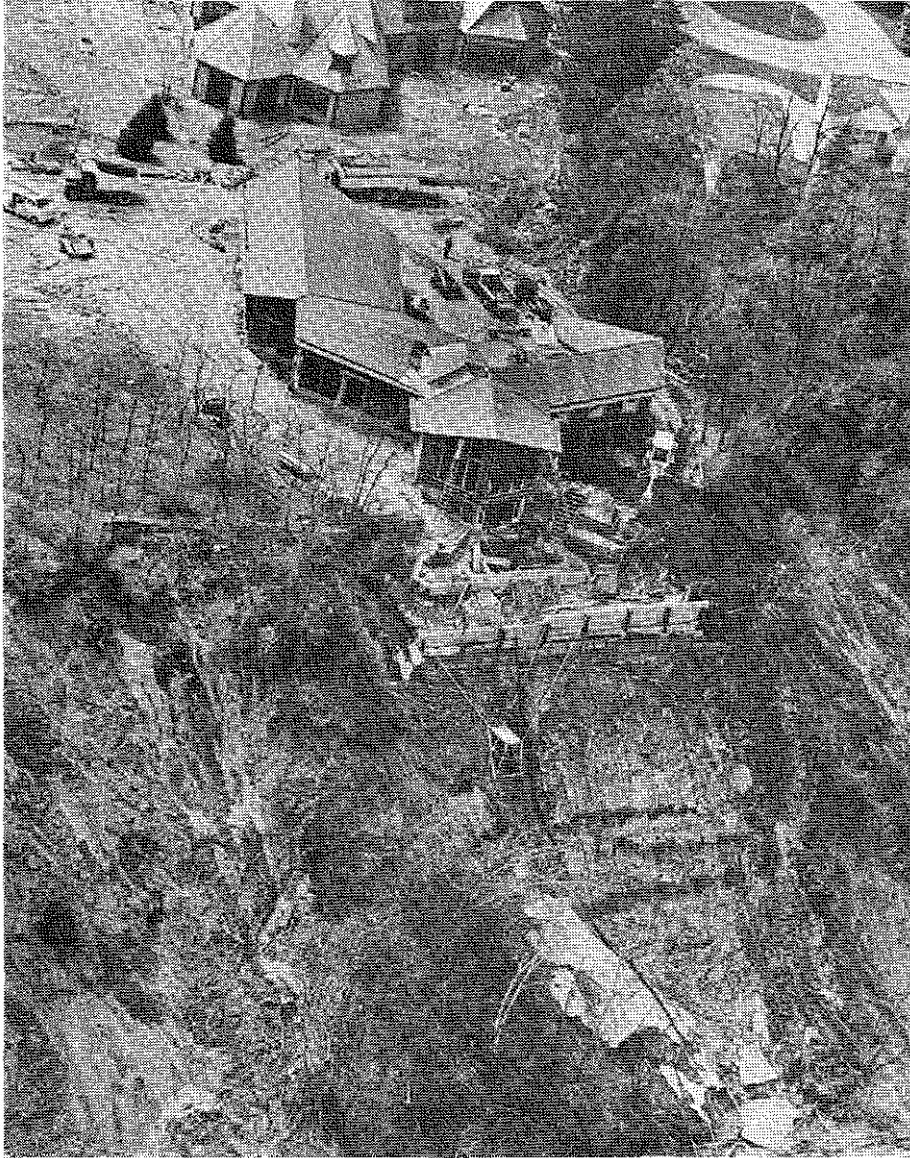
Figure 17. The scars of recent landslides show that this home is being built near the edge of a high, unstable, and actively eroding bluff. Zoning ordinances are needed to protect the unwary citizen. (Milwaukee Journal Photo)
