SHORELINE EROSION IN SOUTHEASTERN WISCONSIN

David W. Hadley

Open-File Report 74-7
40 p.

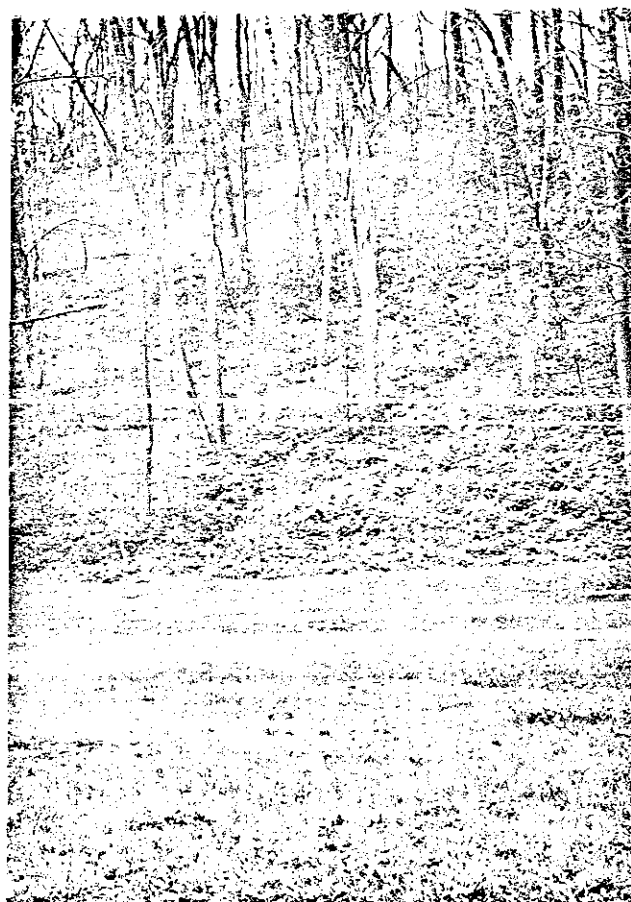
Figure 1

This terrace and low bluff were cut during glacial times when the lake was at a significantly higher level than it is today.

As the ice that deposited the Lake Border Moraines began to retreat into the Lake Michigan basin, the water that was released as the ice melted was trapped between the ice front to the north and the high ground surrounding the basin on the south. The surface of the lake thus formed was about sixty feet above the modern lake level. Shoreline processes along this ancestral lake built beaches, cut bluffs and terraces and formed sand dunes. The remnants of these features are still to be seen in places high above the present shoreline, and attest to the fact that shoreline erosion in the area is far from being a recent phenomenon (Figure 1).

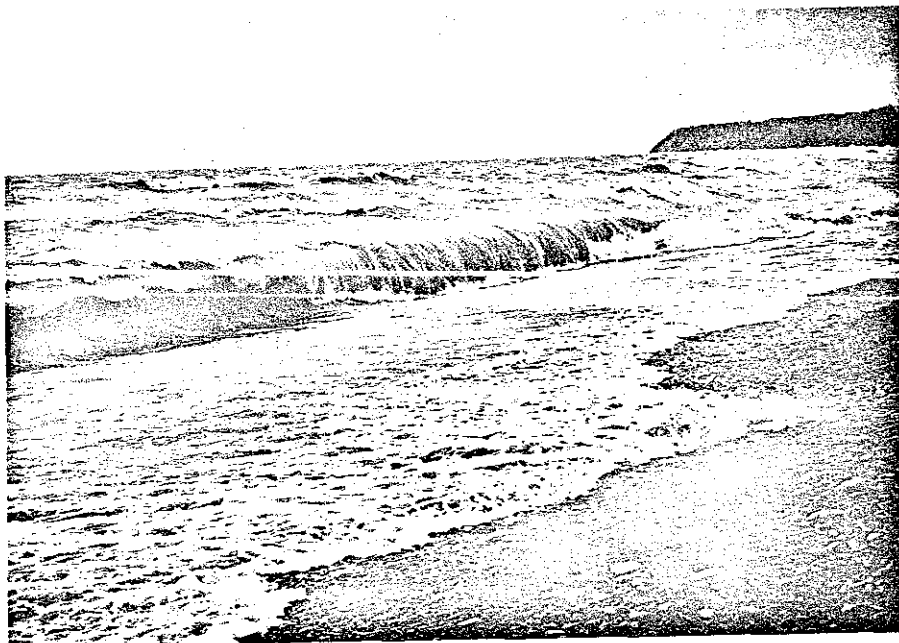
Figure 2

As waves interact with the bottom, they become more closely spaced, increased in height, and eventually fall forward and break against the beach. Notice the pebbles being moved along the beach by the uprushing water.

The picture changes rapidly, however, when a wave nears the shore and enters progressively shallowing water. The wave will begin to interact with the bottom, the speed of the wave will decrease, and the waves will become more closely spaced. As the wave moves into progressively shallower water, it will begin to increase in height and to tilt forward toward the shore. Eventually it becomes unstable and falls forward, or breaks (Figure 2).

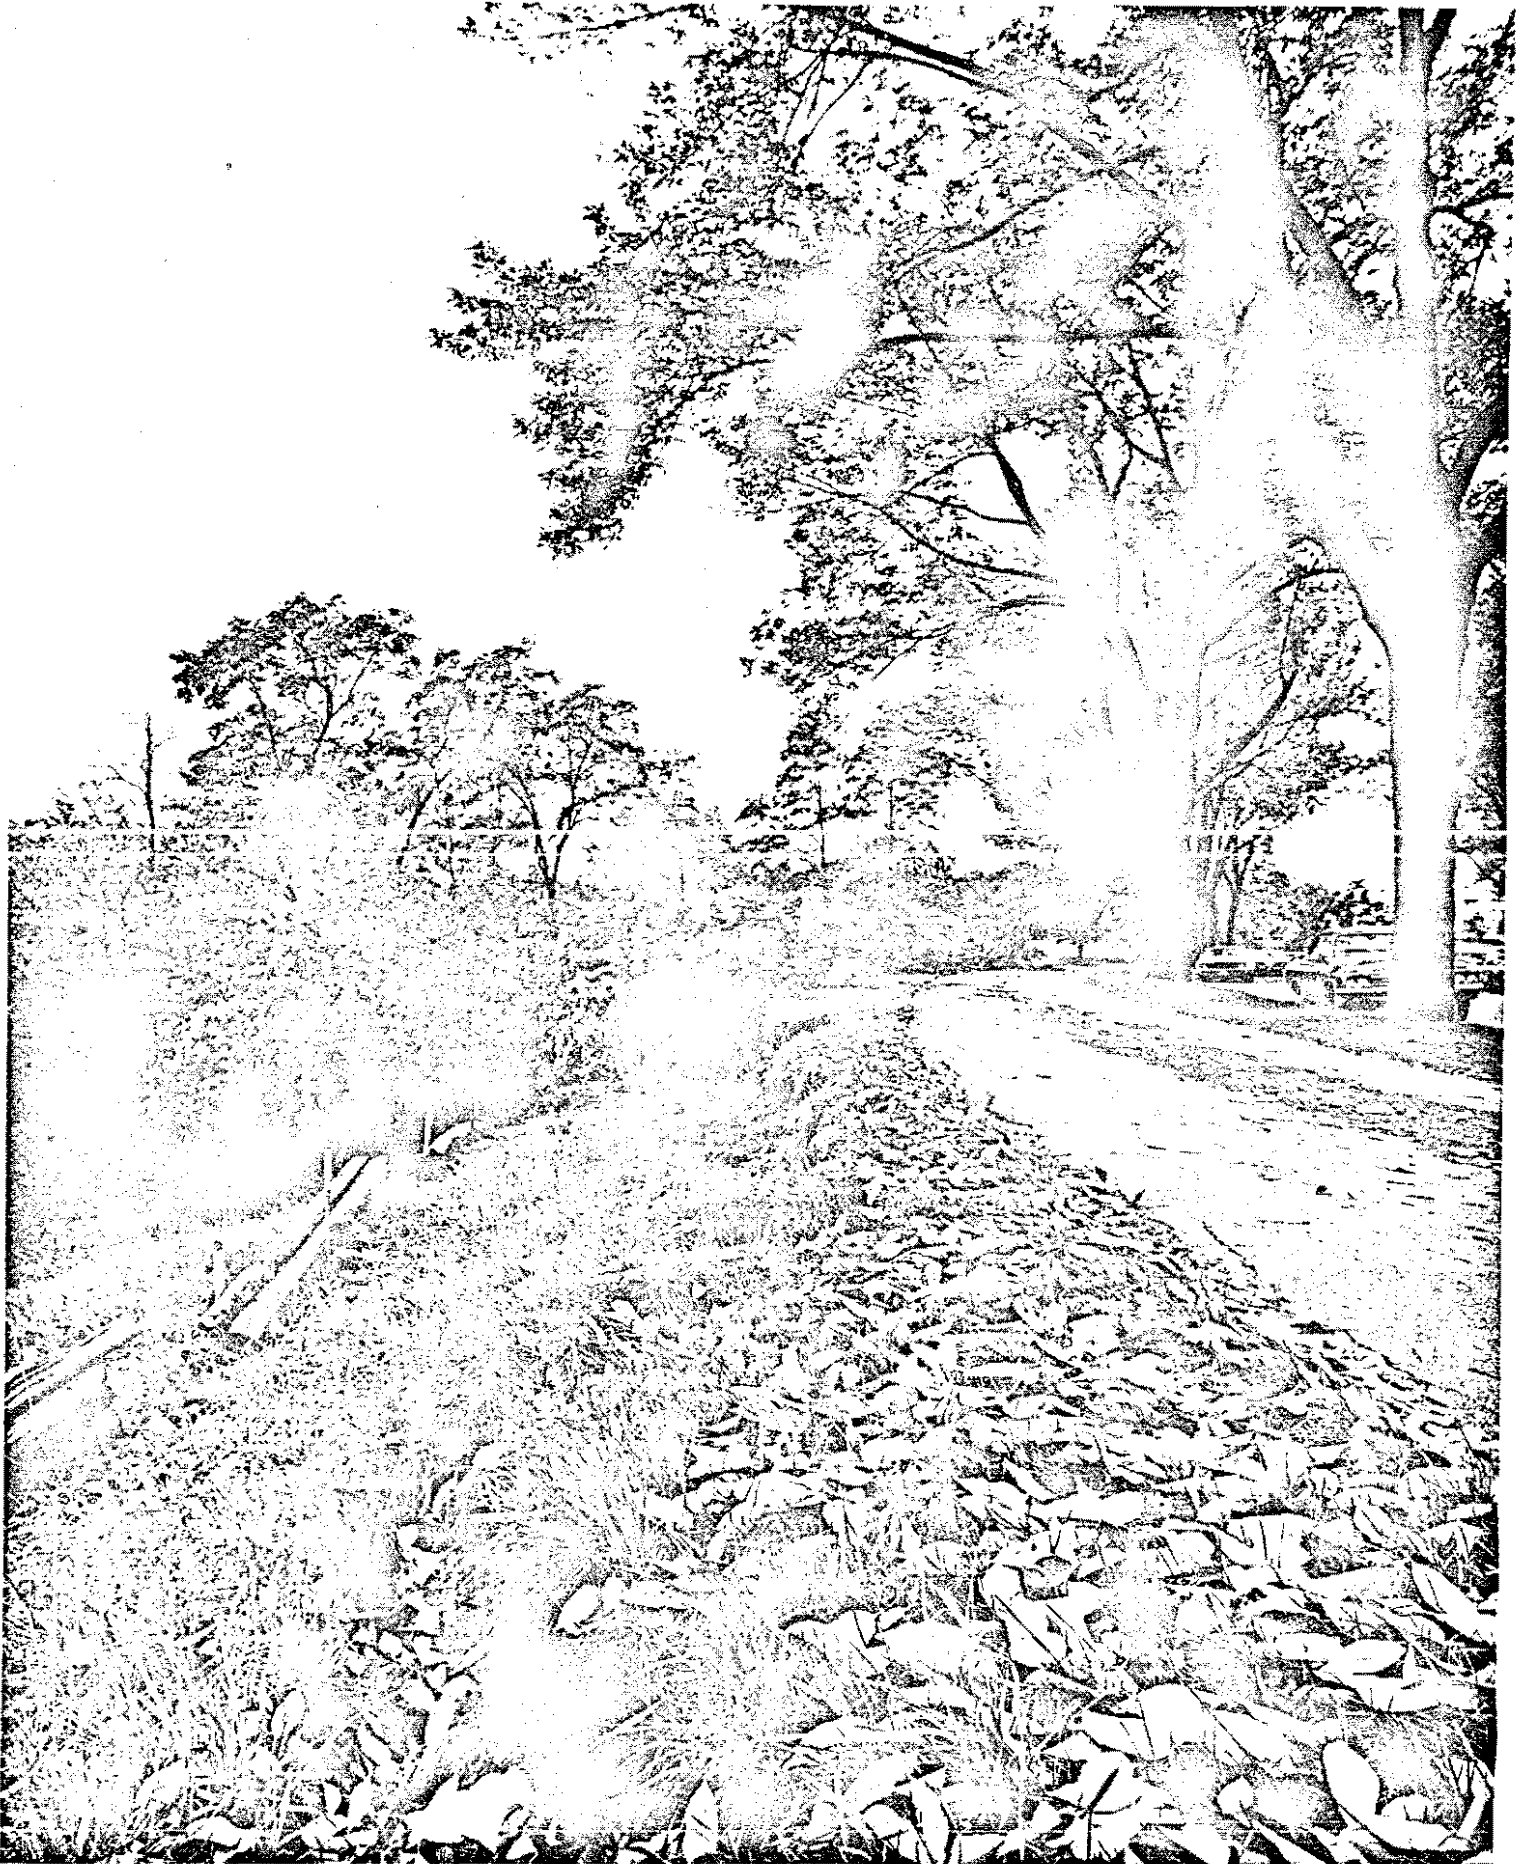
The slumping of a soil mass is often slow in its early stages. The crack shown here is an example of the initial phase in many earth movements of this type.

In some cases, the entire mass of soil will slide rapidly down the failure surface and into the lake below. For the most part, however, slumps move relatively slowly in their early stages (Figure 6). Movement, rather than being continuous, occurs in a series of short spurts. As the soil structure is progressively broken down along the failure plane, movements become larger and more rapid. As the soil mass approaches an equilibrium position, the rate of motion will again slow. Many slumped soil masses temporarily stabilize after moving only part way down the slope. Their movement, however, removes support from the soil behind and this factor, coupled with continued erosion at the base of the bluffs, may cause additional slumping to occur to shoreward. This often leads to a succession of slumps. Along some sections of the shoreline, the bluffs are seen to be composed of a series of short, discontinuous benches. Each of these benches represents the upper surface of an old slumped soil mass (Figure 7). Such sections may appear to be relatively stable, but the writer has observed instances in which the entire sequence of slumps has slipped rapidly into the lake.

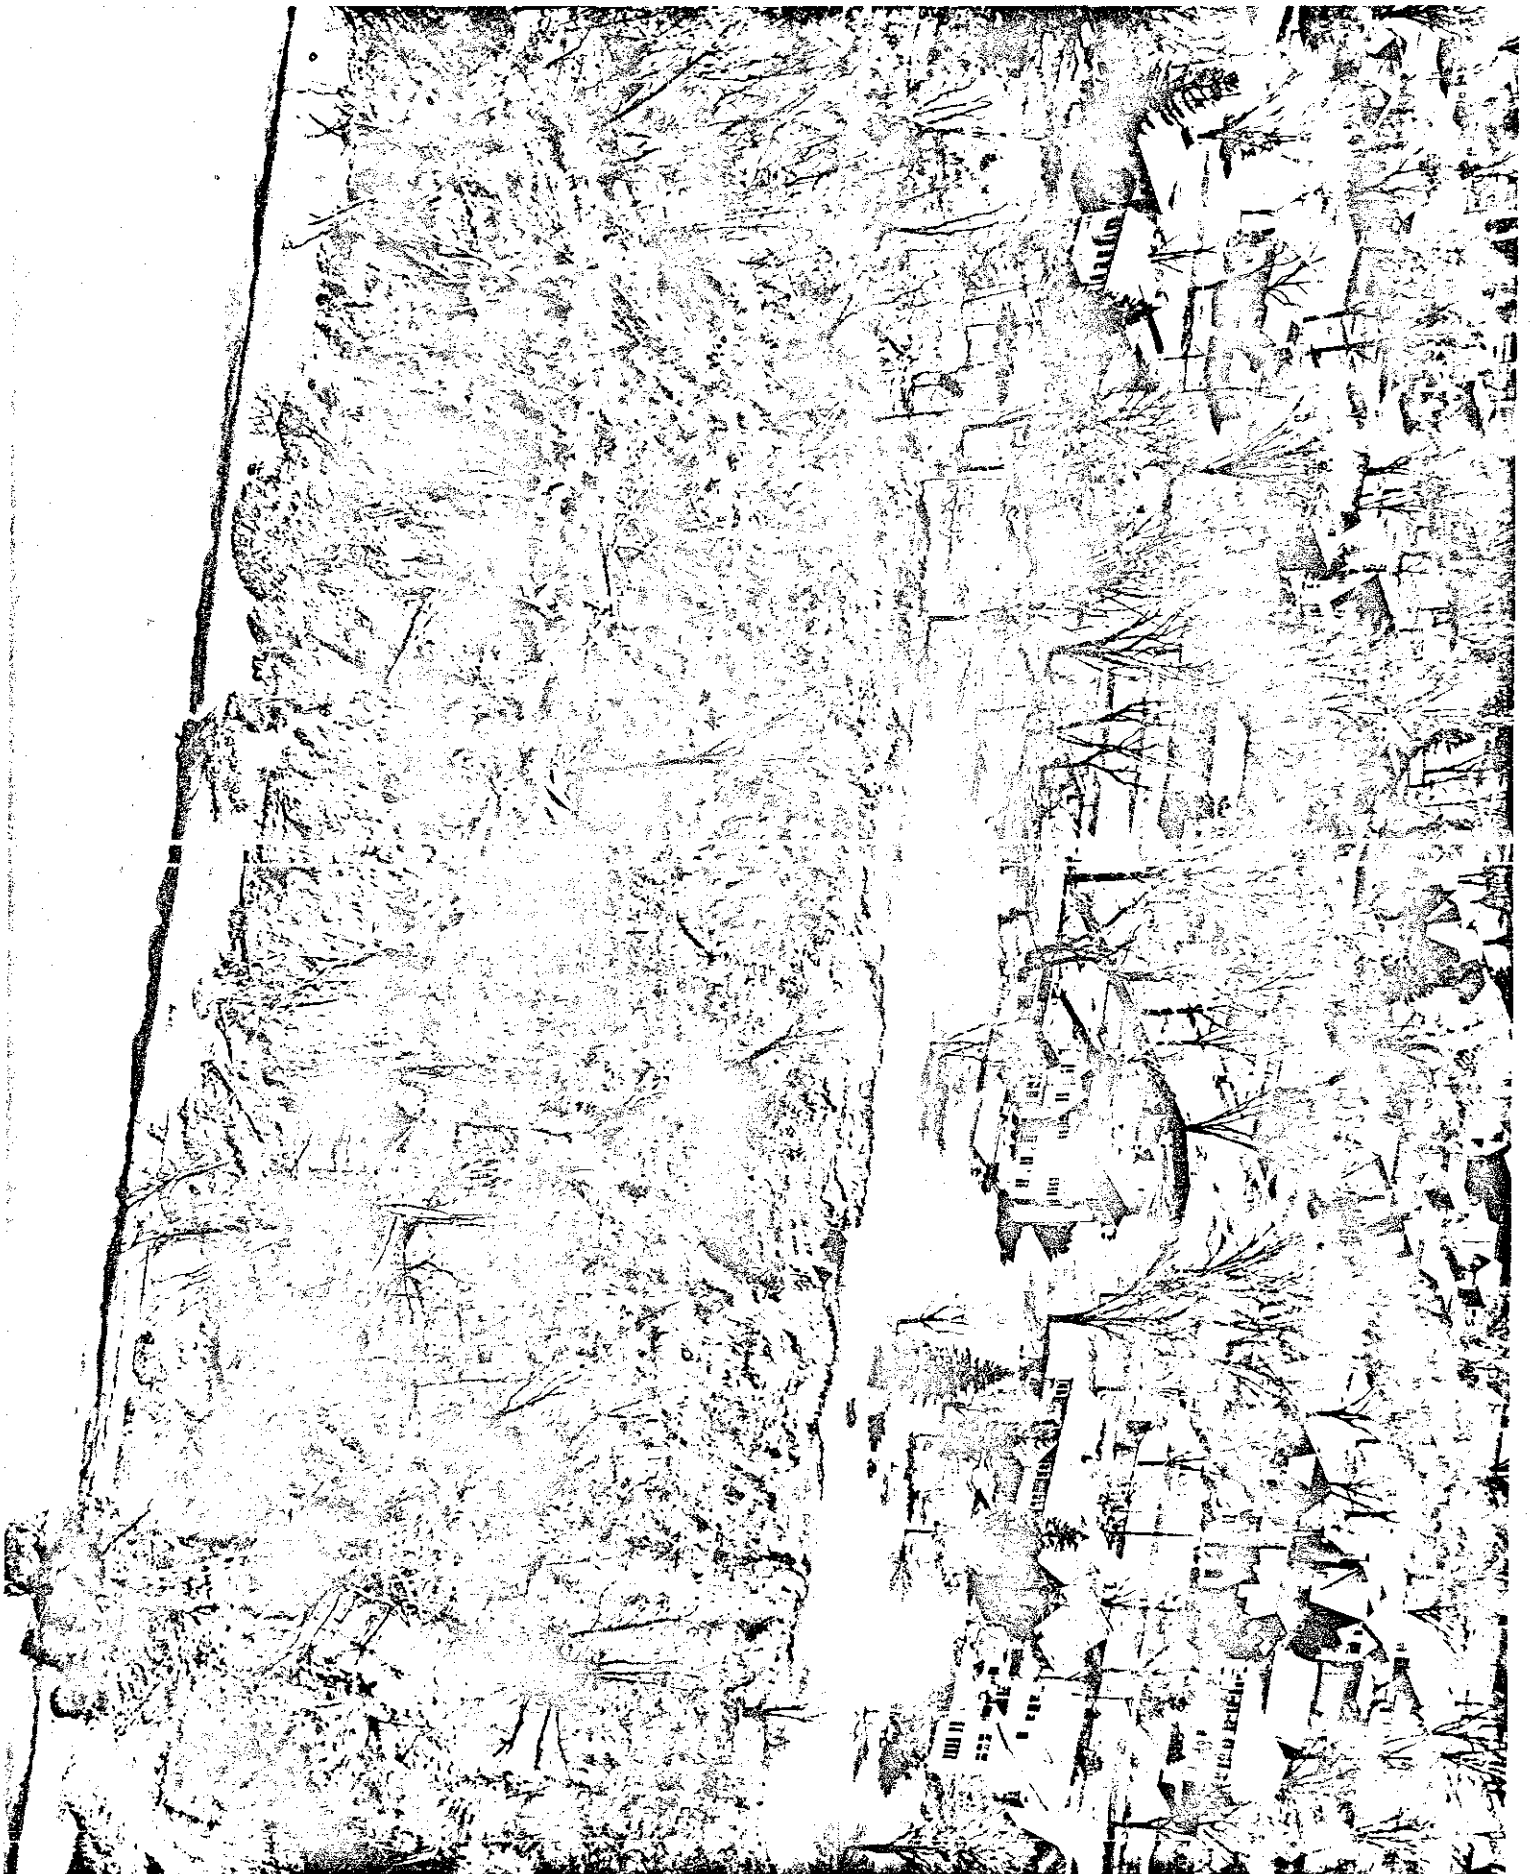
Continuing erosion at the toe of the bluff has caused a series of slumps to occur along this section of the shoreline.

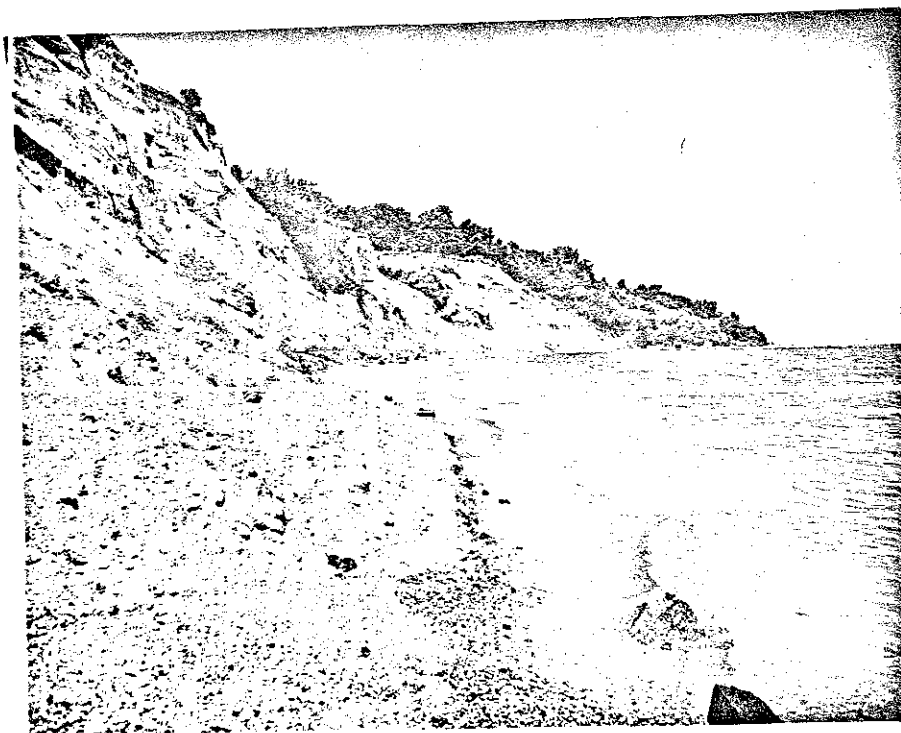
Figure 11

The section of shoreline in the background has been protected by the groins shown in Figure 10. By interrupting the flow of sand along the shore, however, these groins have also contributed to the accelerated erosion of the shoreline shown in the foreground.
