A WEATHERING STUDY OF THE UNIVERSITY BUILDINGS

Burton E. Karges

CIVIL WORKS ADMINISTRATION

PROJECT 79.42

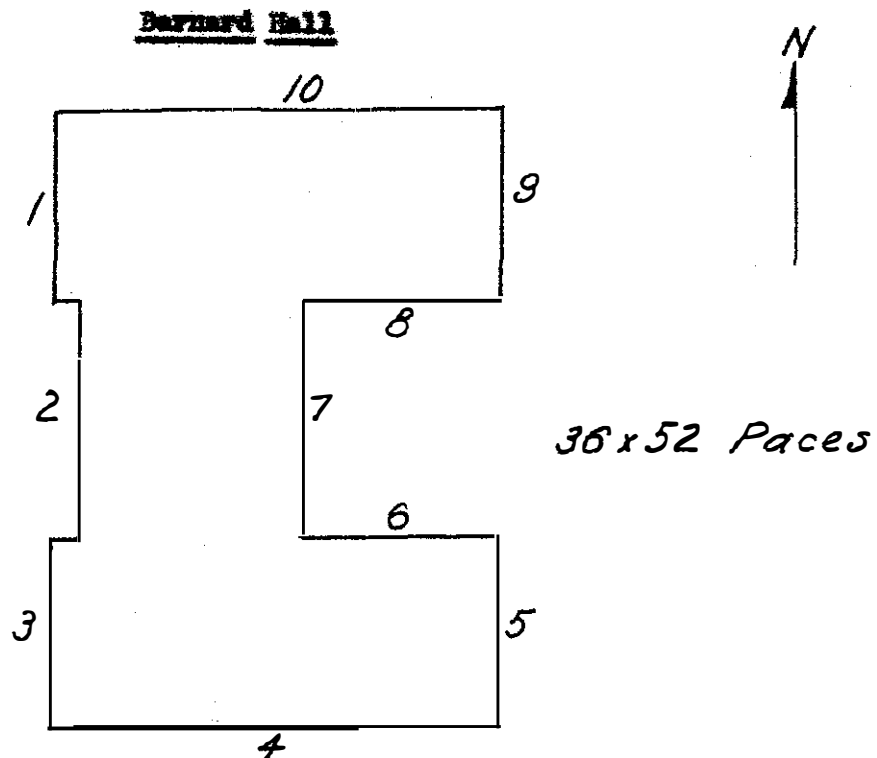
The lower courses are protected from capillary water by a cement gutter. The wall is in excellent condition; even the areas under the window sills are firm and unweathered.

About  $\frac{1}{3}$  of the window sills have decayed to a depth not over  $\frac{1}{8}$  of an inch. The central window between the first and second floors has an ornamental cap stone that projects out 10 inches from the wall and the sill also projects from the wall. Beneath the overhanging part of this cap stone weathering has proceeded to a depth of  $\frac{1}{4}$  of an inch.

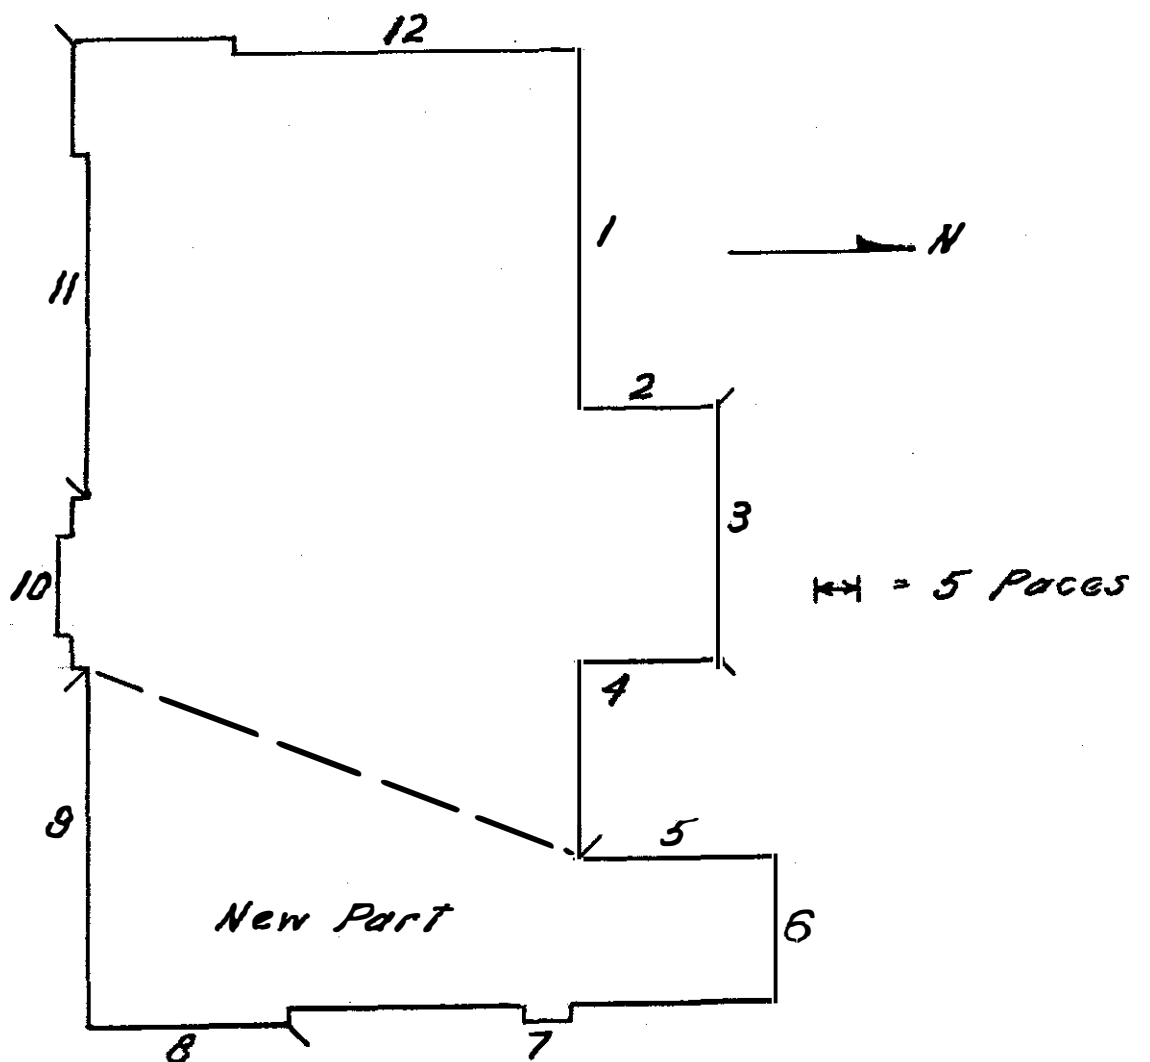
Chemistry Building.

An irregularly weathered zone 2--4 feet wide extends intermittently from the top to the base of the wall at the east end of this location. The depth of the decay usually ranges between  $1/8$  and  $1/4$  of an inch, but in a few blocks it reaches  $3/4$  of an inch. Much of the mortar is gone from the joints of the fourth floor in this weathered band. The decay is related to the down spout just around the corner.
