Wisconsin Geological and Natural History Survey
 Miscellaneous Map 43 1997
 Groundwater Quality Investigation Maps
 of Polk County, Wisconsin
 Plate 4

A part of the Polk County Groundwater Resource Investigation,
 a joint project of the Wisconsin Geological and Natural History
 Survey and the Polk County Board of Supervisors.

Plate 4 Total Hardness in mg/L

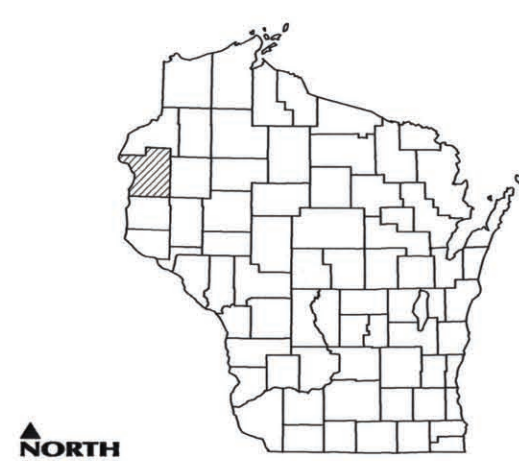
143 total hardness of water sample, in mg/L

GEOLOGIC MATERIALS CONTRIBUTING WATER TO WELL BY SOURCE OF DATA

Note: In areas where sampled wells with the same map symbol are too close together for the symbols to be clearly identified, one symbol is used, and the water-quality results are next to the combined symbol. However, if the map symbols are different, then two slightly separated symbols are shown, and water-quality results are next to each symbol.

Samples were collected June 1992 through August 1993 by M. Hopkins under the supervision of J. Timmons (Polk Land Conservation Department), and were frozen prior to analysis. Chemical analyses were performed July 1992 through March 1993 by K.L. Lund (Wisconsin Geological and Natural History Survey).

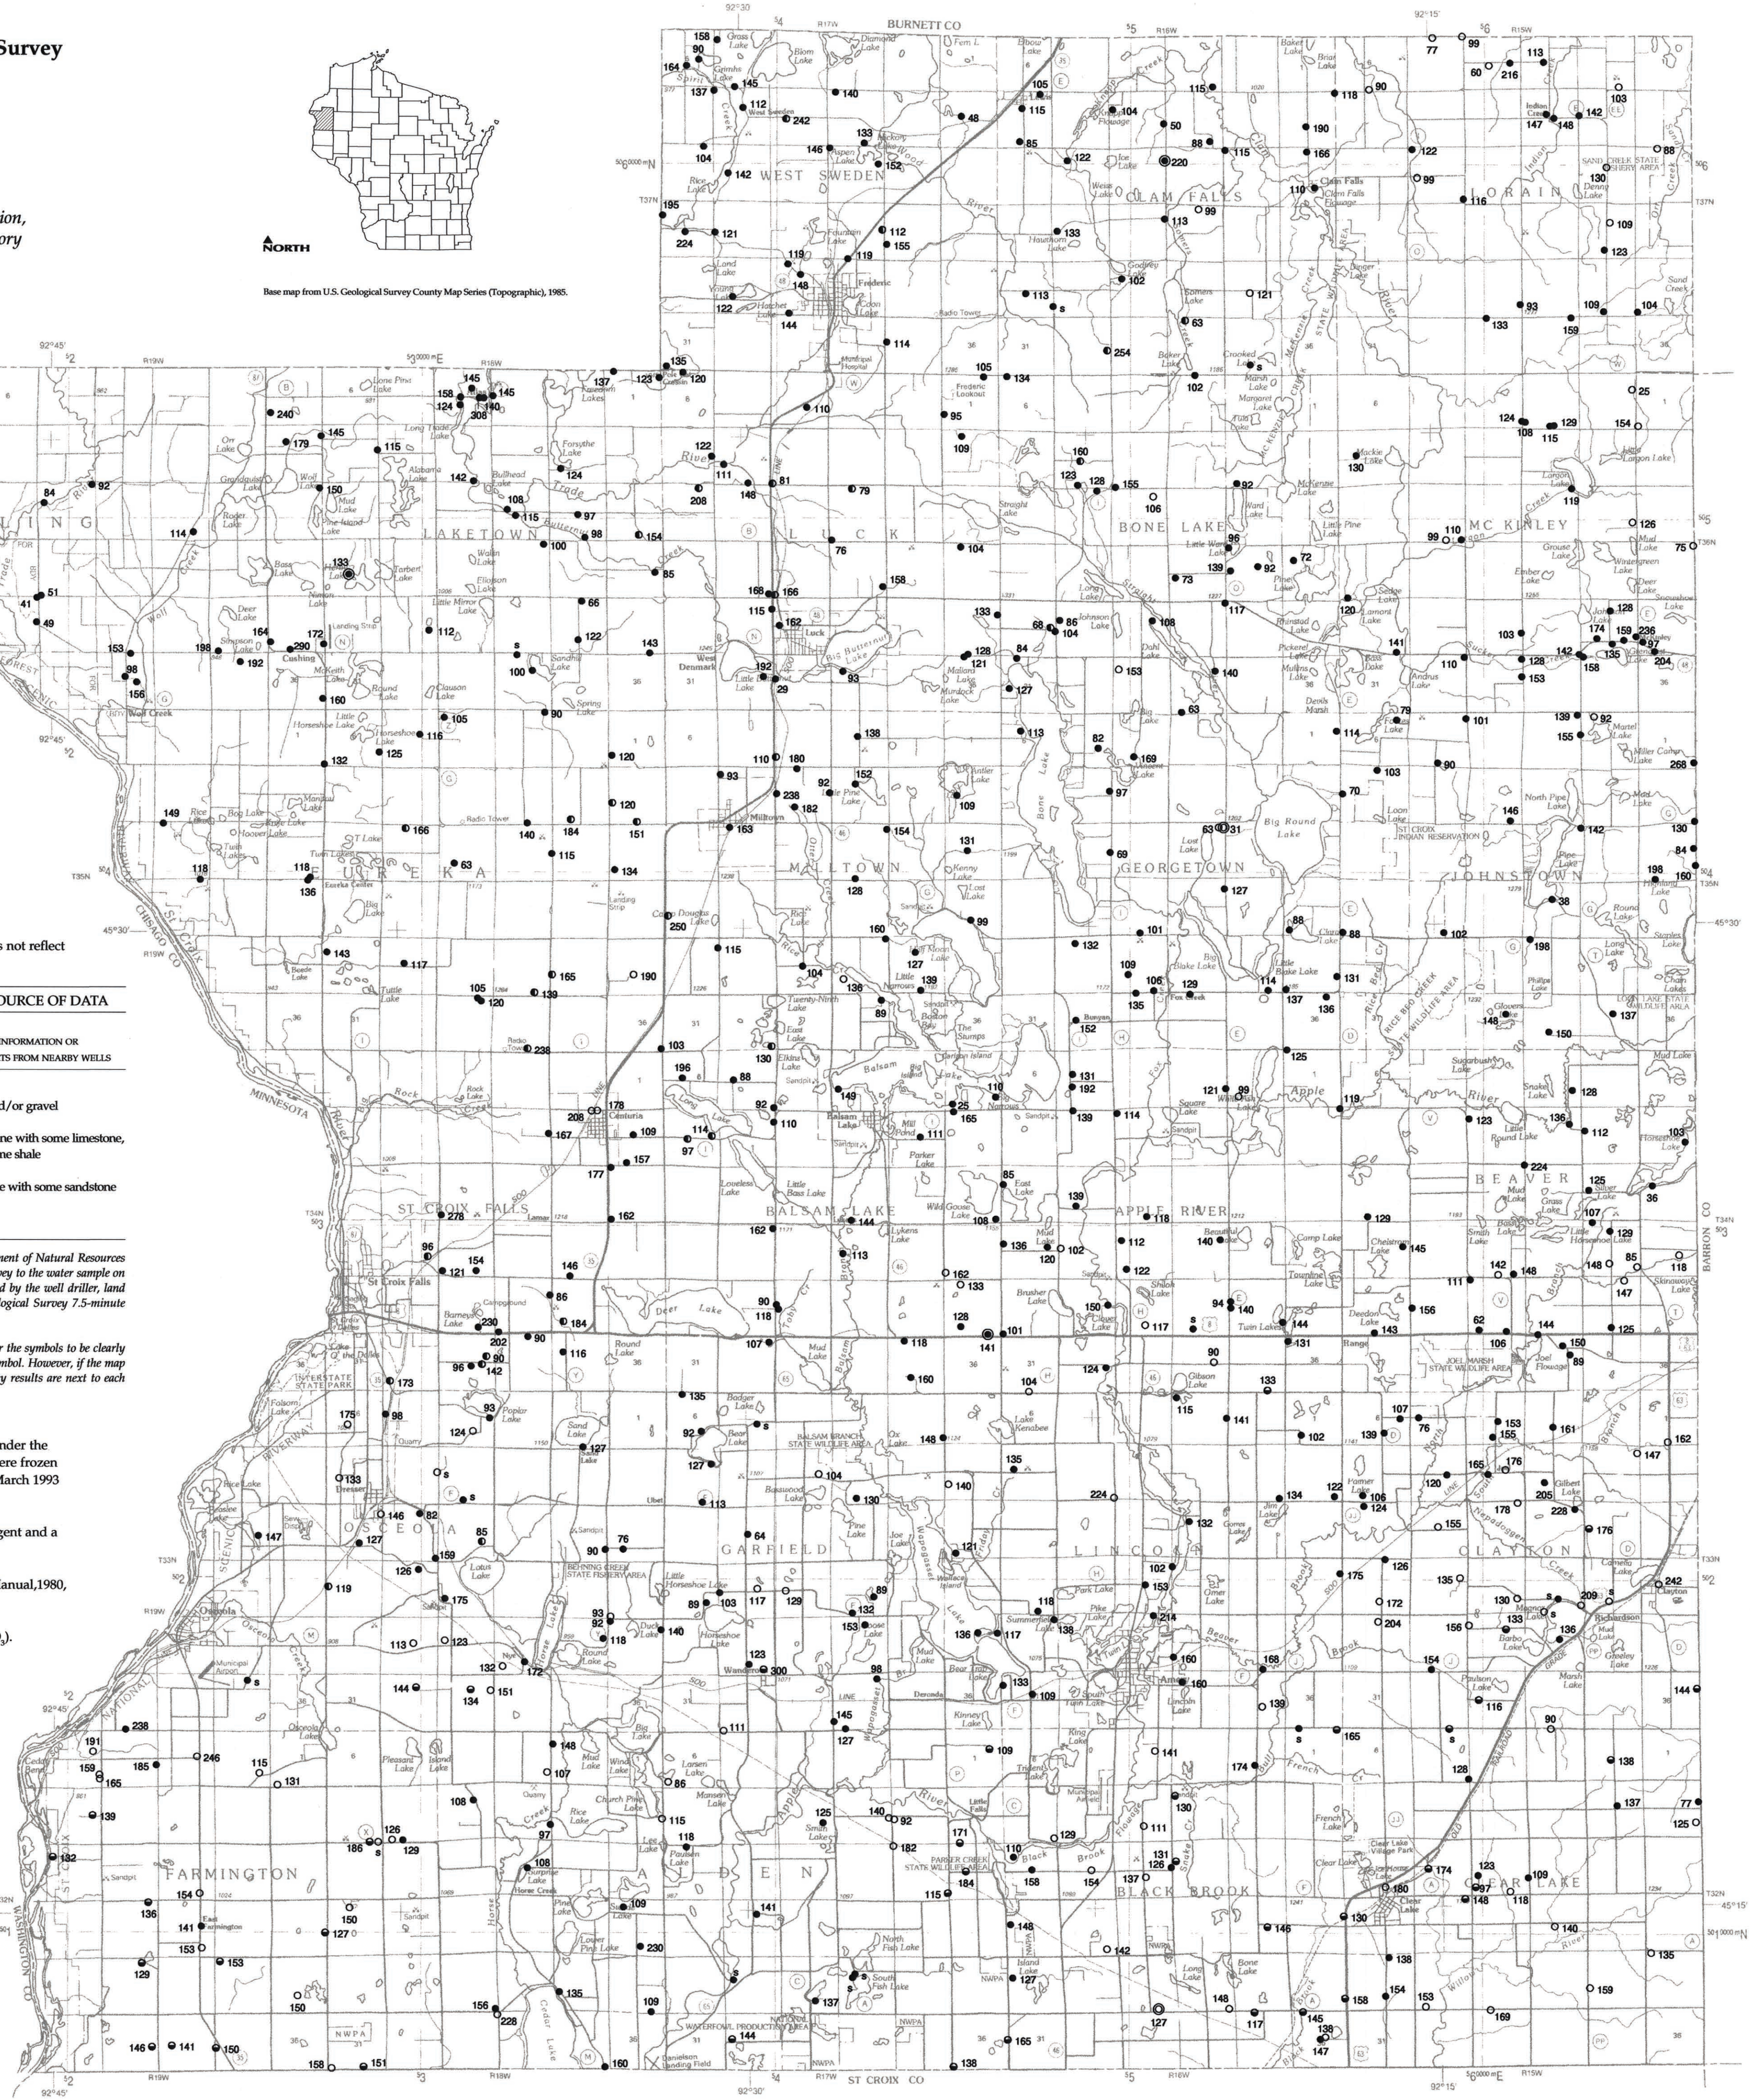
s water sample was treated for hardness (softened) and therefore does not reflect groundwater quality or was not analyzed

FROM WELL CONSTRUCTOR'S REPORT ¹	INFERRED FROM HOMEOWNER INFORMATION OR WELL CONSTRUCTOR'S REPORTS FROM NEARBY WELLS
● sand, clayey sand, and/or gravel	● sand, clayey sand, and/or gravel
○ sandstone, or sandstone with some limestone, or sandstone with some shale	● sandstone, or sandstone with some limestone, or sandstone with some shale
● limestone or limestone with some sandstone	● limestone or limestone with some sandstone
● basalt or granite	● basalt or granite

Analytical method used: EDTA titration, using Man Ver 2 Hardness Reagent and a HACH digital titrator.

Reproducibility: ± 5 mg/L at ≤ 200 mg/L; detection limit 2 mg/L (CaCO₃).
